Intersection ID: 54460 Main Street: STEELE MEADOW RD Cross Street: FLINT HILL DR Location: NW **Overall Compliance: No ADA ID: F57800FFF2E9** Ramp Type: Perp Initial Pass/Fail: Pass **Severity Score:** 22.5

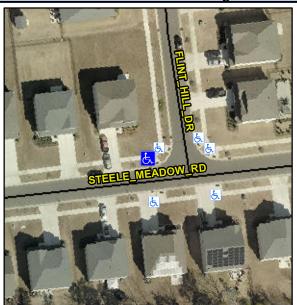
i essible colution	
Possible Solutions:	Co
Remove & Replace Entire Ramp.	N/A
Remove & Replace Gutter.	Yes
	N/A
	N/A
	N/A
	Yes
Surveyor Notes:	Yes
N/A	Yes
	Yes
	N/A
	N/A
PROW/ADA:	Yes
Not Found, R304.2.3, R305.2,	No
R302.7.2, R304.5.4	N/A
	N/A
	N/A
