Access Compliance Report

Public Rights-of-Way

(Curb Ramps)

Intersection ID: 10028420	Main Street: HIGHGROVE_ST	Cross Street: N/A	Location: NE
ADA ID: F57ED1879CF5	Ramp Type: Perp	Initial Pass/Fail: Fail	Overall Compliance: No
Codes/Mitigation Info/Possible Solution		Field Measurements/Component Compliance	
Severity Score: 50

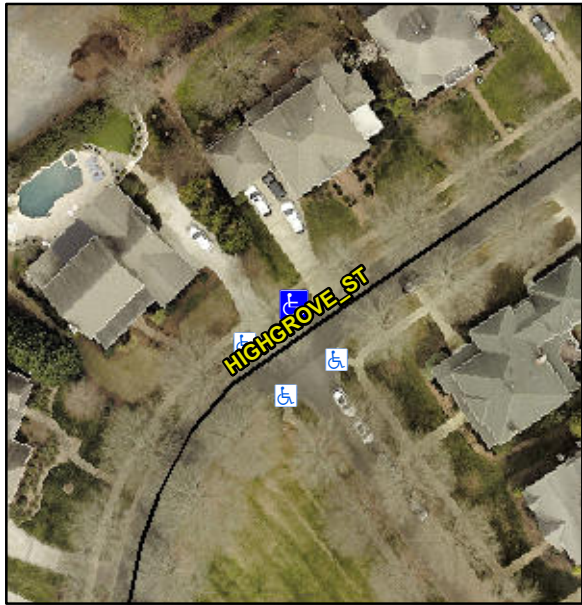
Compliance	Description	Data	Compliance	Description	Data
N/A	Ramp Length (in)	95.0	No	Ramp Slope (%)	12.2
Yes	Ramp Width (in)	54.0	No	Ramp XSlope (%)	7.9
N/A	Flare Type LT	N/A	N/A	Flare Type RT	N/A
N/A	Flare Slope LT (%)	N/A	N/A	Flare Slope RT (%)	N/A
N/A	Flare Traversable LT?	N/A	N/A	Flare Traversable RT?	N/A
N/A	Landing Length (in)	N/A	N/A	DWS Provided?	N/A
N/A	Landing Width (in)	N/A	N/A	DWS Contrast?	N/A
N/A	Landing Slope (%)	N/A	N/A	DWS Length (in)	N/A
N/A	Landing X Slope (%)	N/A	N/A	DWS Full Width?	N/A
N/A	Landing Curb? (Y/N)	N/A	N/A	DWS Offset (in)	N/A
N/A	Shared Landing?	N/A			
N/A	Gutter Ponding?	N/A	N/A	Gutter Slope (%)	N/A
N/A	Gutter Lip Ht (in)	N/A	N/A	Gutter X Slope (%)	N/A
N/A	Painted X Walk1?	No	N/A	Painted X Walk2?	N/A
	X Walk 1 Direction	To SE		X Walk 2 Direction	N/A
N/A	X Walk 1 Width (in)	N/A	N/A	X Walk 2 Width (in)	N/A
	X Walk 1 Slope (%)	3.4		X Walk 2 Slope (%)	N/A
	X Walk 1 X Slope (%)	5.1		X Walk 2 X Slope (%)	N/A

N/A	Ramp inside XWalk1?	N/A	N/A	Ramp inside XWalk2?	N/A
	Road Slope (%)	N/A	N/A	Clear Space?	N/A
	Road X Slope (%)	N/A	N/A	Clear Space to XWalk (in)	N/A
N/A	Any Obstructions?	N/A	N/A	Storm Grate/Utility Hazard?	N/A
	Obstruction Type			Storm Grate/Utility Type	
		N/A			N/A
			Yes	Surface Condition? (G/P)	Good

Possible Solutions:	
	Remove & Replace Entire Ramp.	
	Surveyor Notes:	
	N/A	
	PROW/ADA:	
	Not Found, R304.2.2, R304.5.3	
	Total Cost: \$ 1850.00
