Access Compliance Report

Public Rights-of-Way

(Curb Ramps)

Intersection ID: 14078	Main Street: EAST_BV	Cross Street: SOUTH_BV	Location: NW
ADA ID: F5813C53608F	Ramp Type: Perp	Initial Pass/Fail: Fail	Overall Compliance: No
Severity Score: 12.5			
Codes/Mitigation Info/Possible Solution		Field Measurements/Component Compliance

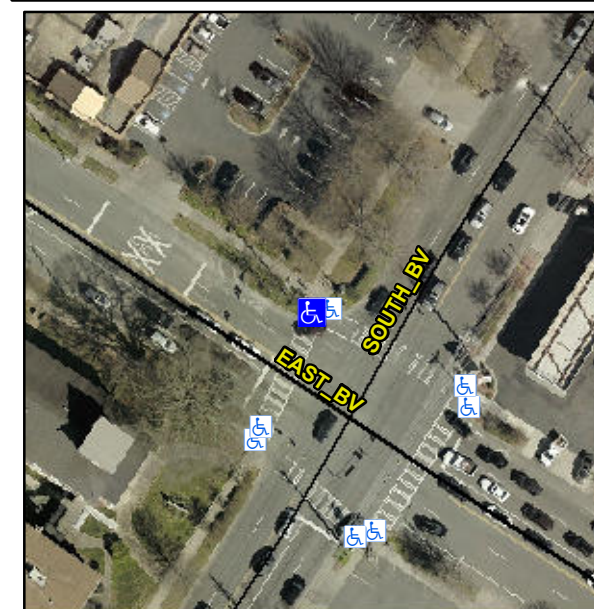
PROW/ADA:

Not Found, R304.5.3

Compliance	Description	Data	Compliance	Description	Data
N/A	Ramp Length (in)	71.0	Yes	Ramp Slope (%)	6.3
Yes	Ramp Width (in)	48.0	No	Ramp XSlope (%)	5.6
N/A	Flare Type LT	N/A	N/A	Flare Type RT	N/A
N/A	Flare Slope LT (%)	N/A	N/A	Flare Slope RT (%)	N/A
N/A	Flare Traversable LT?	N/A	N/A	Flare Traversable RT?	N/A
N/A	Landing Length (in)	N/A	N/A	DWS Provided?	N/A
N/A	Landing Width (in)	N/A	N/A	DWS Contrast?	N/A
N/A	Landing Slope (%)	N/A	N/A	DWS Length (in)	N/A
N/A	Landing X Slope (%)	N/A	N/A	DWS Full Width?	N/A
N/A	Landing Curb? (Y/N)	N/A	N/A	DWS Offset (in)	N/A
N/A	Shared Landing?	N/A			
N/A	Gutter Ponding?	N/A	N/A	Gutter Slope (%)	N/A
N/A	Gutter Lip Ht (in)	N/A	N/A	Gutter X Slope (%)	N/A
N/A	Painted X Walk1?	Yes	N/A	Painted X Walk2?	N/A
	X Walk 1 Direction	To SW		X Walk 2 Direction	N/A
N/A	X Walk 1 Width (in)	107.0	N/A	X Walk 2 Width (in)	N/A
	X Walk 1 Slope (%)	3.2		X Walk 2 Slope (%)	N/A
	X Walk 1 X Slope (%)	4.6		X Walk 2 X Slope (%)	N/A

Possible Solutions:

Remove & Replace Entire Ramp.
