Access Compliance Report

Public Rights-of-Way

(Curb Ramps)

| Intersection ID: 3999 | Main Street: CULLINGFORD_LN | Cross Street: AMBLESIDE_DR | Location: NW |

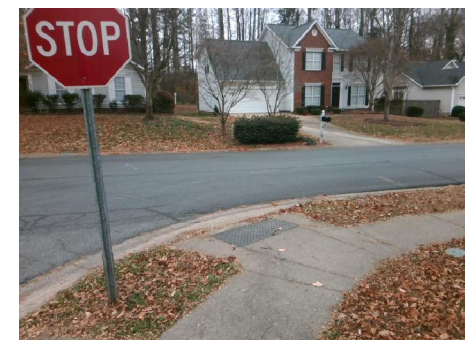
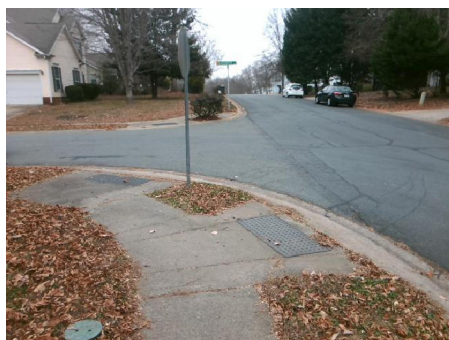
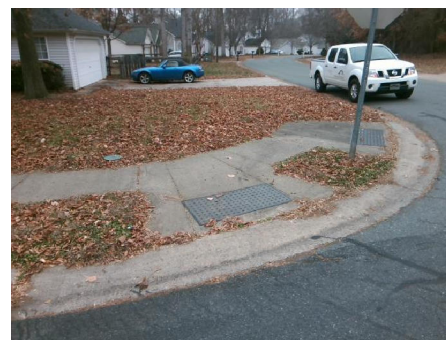
| ADA ID: F58512667BAD | Ramp Type: BlendTrans2 | Initial Pass/Fail: Fail | Overall Compliance: No |
| Severity Score: 36.25 | | | |

| Compliance | Description | Data | Compliance | Description | Data |
|---|---|---|---|---|---|
| No | Ramp Width (in) | 30.0 | Yes | BlendTrans XSlope (%) | 2.6 |

Remove & Replace Curb Ramp With Two New Directional Ramps or Equivalent.

R304.5.1
