# Access Compliance Report

## Public Rights-of-Way

| Intersection ID: 28011 | Main Street: CHANCELOT_LN | Cross Street: LEGACY_CR | Location: NE |
| ADA ID: F58F7026C67F | Ramp Type: Perp | Initial Pass/Fail: Pass | Overall Compliance: No |

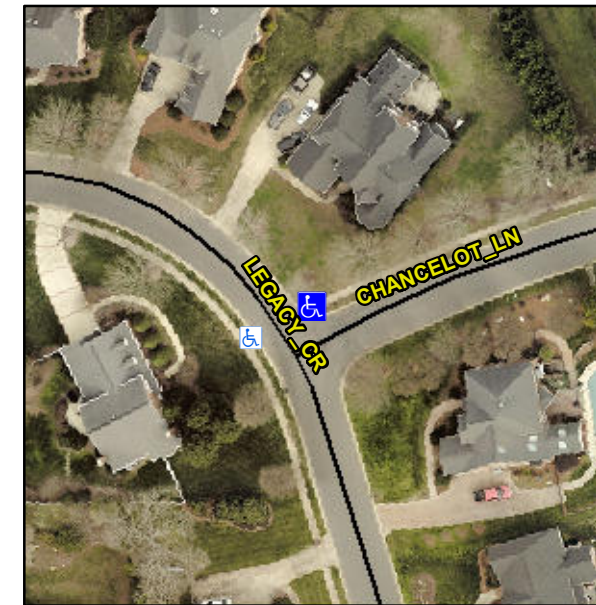
**Not Found, R304.2.1, R304.2.2-Perp,  
R304.3.2-Para, R304.5.3**

| Compliance | Description | Data | Compliance | Description | Data |
|---|---|---|---|---|---|
| No | Landing Length (in) | N/A | Yes | DWS Provided? | Yes |
| No | Landing Width (in) | N/A | Yes | DWS Contrast? | Yes |
| No | Landing Slope (%) | N/A | Yes | DWS Length (in) | 24.0 |
| No | Landing X Slope (%) | N/A | Yes | DWS Full Width? | Yes |
| Yes | Gutter Lip Ht (in) | 0.0 | No | Gutter X Slope (%) | 2.3 |

**Remove & Replace Entire Ramp.  
Remove & Replace Gutter.**
