Access Compliance Report

Public Rights-of-Way

(Curb Ramps)

Intersection ID: 11691	Main Street: E_18TH_ST	Cross Street: N_MCDOWELL_ST	Location: N
ADA ID: F5939CEDA465	Ramp Type: Perp	Initial Pass/Fail: Fail	Overall Compliance: No
Severity Score: 61.25			
Codes/Mitigation Info/Possible Solution		Field Measurements/Component Compliance

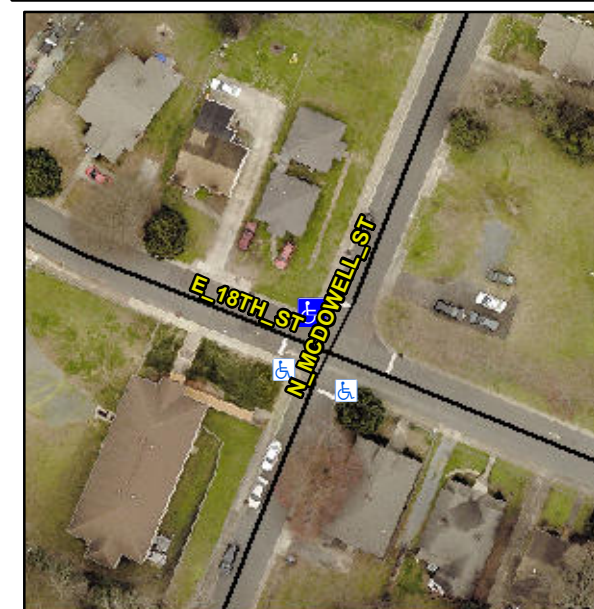
Not Found, R304.5.1, R304.2.2, R304.5.3, R302.7

Compliance	Description	Data	Compliance	Description	Data
N/A	Ramp Length (in)	69.0	No	Ramp Slope (%)	13.2
No	Ramp Width (in)	47.0	No	Ramp XSlope (%)	5.2
N/A	Flare Type LT	N/A	N/A	Flare Type RT	N/A
N/A	Flare Slope LT (%)	N/A	N/A	Flare Slope RT (%)	N/A
N/A	Flare Traversable LT?	N/A	N/A	Flare Traversable RT?	N/A
N/A	Landing Length (in)	N/A	N/A	DWS Provided?	N/A
N/A	Landing Width (in)	N/A	N/A	DWS Contrast?	N/A
N/A	Landing Slope (%)	N/A	N/A	DWS Length (in)	N/A
N/A	Landing X Slope (%)	N/A	N/A	DWS Full Width?	N/A
N/A	Landing Curb? (Y/N)	N/A	N/A	DWS Offset (in)	N/A
N/A	Shared Landing?	N/A			
N/A	Gutter Ponding?	N/A	N/A	Gutter Slope (%)	N/A
N/A	Gutter Lip Ht (in)	N/A	N/A	Gutter X Slope (%)	N/A
N/A	Painted X Walk1?	No	N/A	Painted X Walk2?	N/A
	X Walk 1 Direction	To SW		X Walk 2 Direction	N/A
N/A	X Walk 1 Width (in)	N/A	N/A	X Walk 2 Width (in)	N/A
	X Walk 1 Slope (%)	6.3		X Walk 2 Slope (%)	N/A
	X Walk 1 X Slope (%)	6.2		X Walk 2 X Slope (%)	N/A

N/A	Ramp inside XWalk1?	N/A	N/A	Ramp inside XWalk2?	N/A
	Road Slope (%)	N/A	N/A	Clear Space?	N/A
	Road X Slope (%)	N/A	N/A	Clear Space to XWalk (in)	N/A
N/A	Any Obstructions?	N/A	N/A	Storm Grate/Utility Hazard?	N/A
	Obstruction Type			Storm Grate/Utility Type	
		N/A			N/A
		No		Surface Condition? (G/P)	Poor

Possible Solutions:

Remove & Replace Entire Ramp.
