## **Access Compliance Report Public Rights-of-Way** (Curb Ramps)

Intersection ID: 9469 Main Street: BUNGALOW RD Cross Street: CLYDE\_DR Location: W **Overall Compliance: No** ADA ID: F5950671C2C8 Ramp Type: PerpDiag Initial Pass/Fail: Fail **Severity Score:** 35

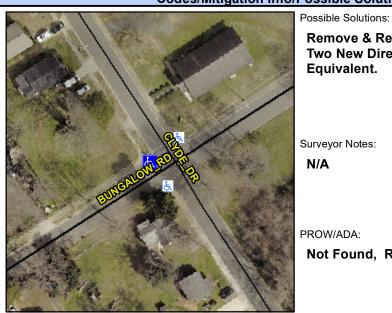
Field Measurements/Component Compliance						
Compl	iance Description	Data	Comp	liance Description	Data	
N/A	Ramp Length (in)	81.0	Yes	Ramp Slope (%)	5.5	
No	Ramp Width (in)	30.0	Yes	Ramp XSlope (%)	1.5	
N/A	Flare Type LT	N/A	N/A	Flare Type RT	N/A	
N/A	Flare Slope LT (%)	N/A	N/A	Flare Slope RT (%)	N/A	
N/A	Flare Traversable LT?	N/A	N/A	Flare Traversable RT?	N/A	
N/A	Landing Length (in)	N/A	N/A	DWS Provided?	N/A	
N/A	Landing Width (in)	N/A	N/A	DWS Contrast?	N/A	
N/A	Landing Slope (%)	N/A	N/A	DWS Length (in)	N/A	
N/A	Landing X Slope (%)	N/A	N/A	DWS Full Width?	N/A	
N/A	Landing Curb? (Y/N)	N/A	N/A	DWS Offset (in)	N/A	
N/A	Shared Landing?	N/A				
N/A	Gutter Ponding?	N/A	N/A	Gutter Slope (%)	N/A	
N/A	Gutter Lip Ht (in)	N/A	N/A	Gutter X Slope (%)	N/A	
N/A	Painted X Walk1?	No	N/A	Painted X Walk2?	No	
	X Walk 1 Direction	To SE		X Walk 2 Direction	To NE	
N/A	X Walk 1 Width (in)	N/A	N/A	X Walk 2 Width (in)	N/A	
	X Walk 1 Slope (%)	0.6		X Walk 2 Slope (%)	1.9

X Walk 1 X Slope (%)	1.9		X Walk 2 X Slope (%)	0.9	
N/A	Ramp inside XWalk1?	N/A	N/A	Ramp inside XWalk2?	N/A	
	Road Slope (%)	1.5	N/A	Clear Space?	N/A	
	Road X Slope (%)	2.0	N/A	Clear Space to XWalk (in)	N/A	
N/A	Any Obstructions?	N/A	N/A	Storm Grate/Utility Hazard?	N/A	
	Obstruction Type			Storm Grate/Utility Type		
		N/A			N/A	
			Yes	Surface Condition? (G/P)	Good

BUNGALOW Street 1 Name Stop Condition-Street 2 Street 2 Name **CLYDE** Stop Condition-Street 1 StopS Remove & Replace Curb Ramp With **Two New Directional Ramps or** Equivalent.
