# Access Compliance Report

## Public Rights-of-Way

| Intersection ID: 28108 | Main Street: BERITSTRASSE_CT | Cross Street: DARBY_CHASE_DR | Location: SW |
| ADA ID: F5969BDAEC1F | Ramp Type: Perp | Initial Pass/Fail: Pass | Overall Compliance: No |

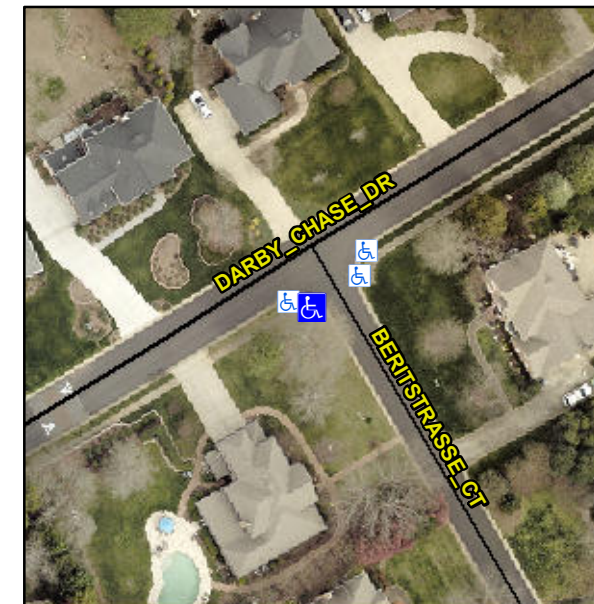
**R304.2.1, R304.2.2-Perp, R304.3.2-  
Para, R305, R302.7.2, R304.5.4**

| Compliance | Description | Data | Compliance | Description | Data |
|---|---|---|---|---|---|
| No | Landing Length (in) | 45.5 | No | DWS Provided? | No |
| No | Landing Slope (%) | 2.4 | N/A | DWS Length (in) | N/A |
| Yes | Gutter Ponding? | No | No | Gutter Slope (%) | 8.1 |
| No | Gutter Lip Ht (in) | 1.0 | Yes | Gutter X Slope (%) | 0.8 |

**Remove & Replace Entire Ramp.  
Remove & Replace Gutter.**

Total Cost: \$ 2600.00
