# Access Compliance Report

## Public Rights-of-Way

### (Curb Ramps)

Intersection ID: 10017494		Main Street: MILHAVEN_LN		Cross Street: N/A		Location: NW													
ADA ID: F599110D32BE		Ramp Type: Directional1		Initial Pass/Fail: Fail		Overall Compliance: No		Severity Score: 13.75											
Codes/Mitigation Info/Possible Solution				Field Measurements/Component Compliance															
<div>

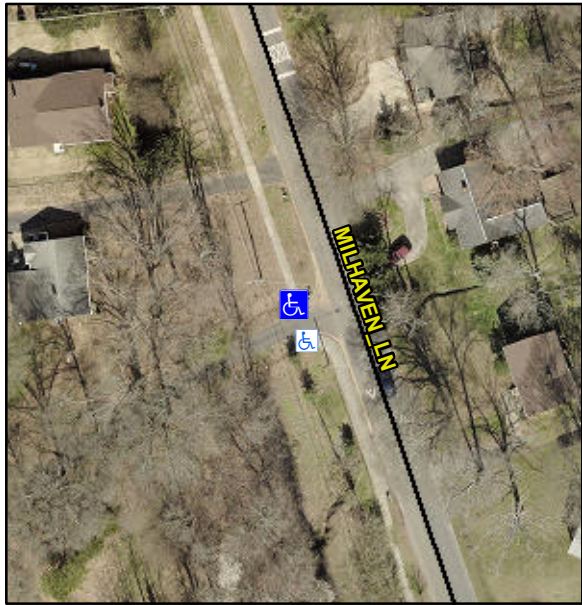
</div> <div>Street 1 NameENTRANCE</div> <div>Stop Condition-Street 1None</div> <div>Street 2 NameN/A</div> <div>Stop Condition-Street 2N/A</div>				Possible Solutions:		Compliance		Description		Data		Compliance		Description		Data			
				Remove & Replace Entire Ramp.		N/A		Ramp Length (in)		103.5		N/A		Grade Break?		N/A		N/A	
						Yes		Ramp Width (in)		65.0		N/A		Grade Break Slope (%)		0.0		0.0	
						No		Ramp Slope (%)		10.6		N/A		Grade Break XSlope (%)		0.0		0.0	
						Yes		Ramp XSlope (%)		2.5									
						N/A		Flare Type LT		N/A		N/A		Flare Type RT		N/A		N/A	
						N/A		Flare Slope LT (%)		N/A		N/A		Flare Slope RT (%)		0.0		0.0

N/A		Flare Traversable LT?		N/A		N/A		Flare Traversable RT?		N/A		N/A	
						N/A		Landing Length (in)		0.0		N/A		DWS Provided?		N/A		N/A	
						N/A		Landing Width (in)		0.0		N/A		DWS Contrast?		N/A		N/A	
						N/A		Landing Slope (%)		0.0		N/A		DWS Length (in)		N/A		N/A	
						N/A		Landing X Slope (%)		0.0		N/A		DWS Full Width?		N/A		N/A	
						N/A		Landing Curb? (Y/N)		N/A		N/A		DWS Offset LT (in)		N/A		N/A	
						N/A		Shared Landing?		N/A		N/A		DWS Offset RT (in)		N/A		N/A	
						N/A		Gutter Ponding?		0.0		N/A		Gutter Slope (%)		N/A		N/A	
						N/A		Gutter Lip Ht (in)		0.0		N/A		Gutter X Slope (%)		N/A		N/A	
						N/A		Painted X Walk1?		No				Road Slope (%)		2.0		2.0	
								X Walk 1 Direction		To SE				Road X Slope (%)		5.9		5.9	
								X Walk 1 Width (in)		N/A				Clear Space?		N/A		N/A	
								X Walk 1 Slope (%)		2.0		N/A		Clear Space to XWalk (in)		N/A		N/A	
				X Walk 1 X Slope (%)		5.9		N/A		Storm Grate/Utility Hazard?		N/A		N/A

N/A		Ramp inside XWalk1?		N/A		Storm Grate/Utility Type									
				N/A		Any Obstructions?		N/A				N/A		N/A					
						Obstruction Type				Yes		Surface Condition? (G/P)		Good					
								N/A		N/A		Curb Slope (%)		17.9					
				Total Cost:		\$		1600.00
