# Access Compliance Report

## Public Rights-of-Way

### (Curb Ramps)

Intersection ID: 47140	Main Street: DARLINGTON_RD	Cross Street: RESTORATION_DR	Location:	N
ADA ID: F5A9D90619D0	Ramp Type: PerpDiag	Initial Pass/Fail: Fail	Overall Compliance: No	Severity Score: 10

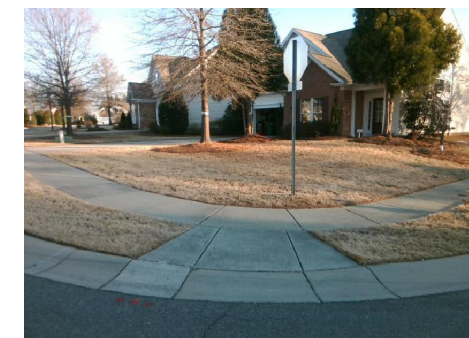
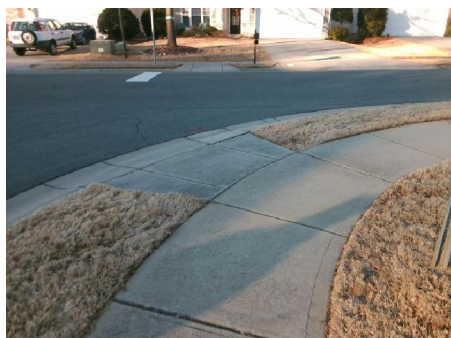
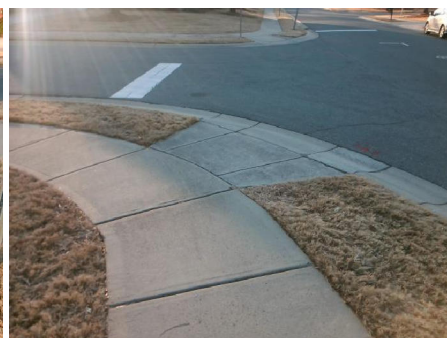
**Not Found, R304.5.1, R304.5.3**

Compliance	Description	Data	Compliance	Description	Data
N/A	Ramp Length (in)	47.5	Yes	Ramp Slope (%)	8.0
No	Ramp Width (in)	38.0	No	Ramp XSlope (%)	2.9
N/A	Flare Type LT	N/A	N/A	Flare Type RT	N/A
N/A	Flare Slope LT (%)	N/A	N/A	Flare Slope RT (%)	N/A
N/A	Flare Traversable LT?	N/A	N/A	Flare Traversable RT?	N/A
N/A	Landing Length (in)	N/A	N/A	DWS Provided?	N/A
N/A	Landing Width (in)	N/A	N/A	DWS Contrast?	N/A
N/A	Landing Slope (%)	N/A	N/A	DWS Length (in)	N/A
N/A	Landing X Slope (%)	N/A	N/A	DWS Full Width?	N/A
N/A	Landing Curb? (Y/N)	N/A	N/A	DWS Offset (in)	N/A
N/A	Shared Landing?	N/A			
N/A	Gutter Ponding?	N/A	N/A	Gutter Slope (%)	N/A
N/A	Gutter Lip Ht (in)	N/A	N/A	Gutter X Slope (%)	N/A
N/A	Painted X Walk1?	No	N/A	Painted X Walk2?	No
	X Walk 1 Direction	To SW		X Walk 2 Direction	To SE
N/A	X Walk 1 Width (in)	N/A	N/A	X Walk 2 Width (in)	N/A
	X Walk 1 Slope (%)	4.6		X Walk 2 Slope (%)	0.8
	X Walk 1 X Slope (%)	1.9		X Walk 2 X Slope (%)	2.9

N/A	Ramp inside XWalk1?	N/A	N/A	Ramp inside XWalk2?	N/A
	Road Slope (%)	1.9	N/A	Clear Space?	N/A
	Road X Slope (%)	1.9	N/A	Clear Space to XWalk (in)	N/A
N/A	Any Obstructions?	N/A	N/A	Storm Grate/Utility Hazard?	N/A
	Obstruction Type			Storm Grate/Utility Type	
		N/A			N/A
			Yes	Surface Condition? (G/P)	Good

**Remove & Replace Curb Ramp With Two New Directional Ramps or Equivalent.**
