Access Compliance Report

Public Rights-of-Way

(Curb Ramps)

Intersection ID: 10263	Main Street: BRICE_ST	Cross Street: PARKWAY_AV	Location: S
ADA ID: F5C760A846A4	Ramp Type: Perp	Initial Pass/Fail: Fail	Overall Compliance: No
Severity Score: 26.25			
Codes/Mitigation Info/Possible Solution		Field Measurements/Component Compliance

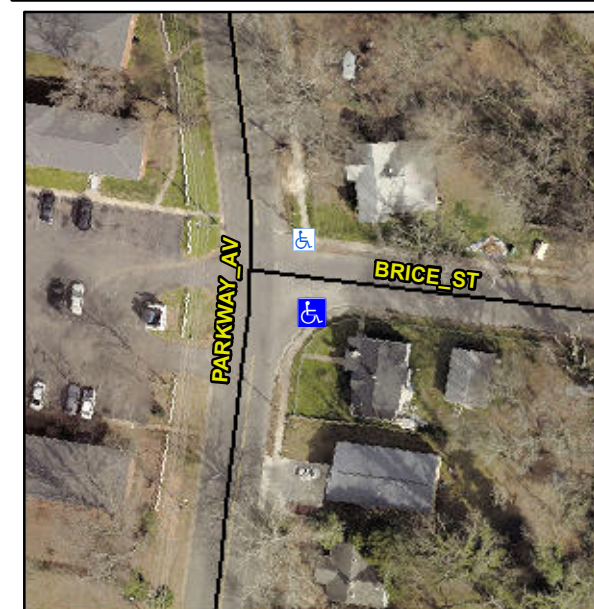
Not Found, R304.2.2, R304.5.3

Compliance	Description	Data	Compliance	Description	Data
N/A	Ramp Length (in)	25.0	No	Ramp Slope (%)	12.3
Yes	Ramp Width (in)	48.0	No	Ramp XSlope (%)	2.7
N/A	Flare Type LT	N/A	N/A	Flare Type RT	N/A
N/A	Flare Slope LT (%)	N/A	N/A	Flare Slope RT (%)	N/A
N/A	Flare Traversable LT?	N/A	N/A	Flare Traversable RT?	N/A
N/A	Landing Length (in)	N/A	N/A	DWS Provided?	N/A
N/A	Landing Width (in)	N/A	N/A	DWS Contrast?	N/A
N/A	Landing Slope (%)	N/A	N/A	DWS Length (in)	N/A
N/A	Landing X Slope (%)	N/A	N/A	DWS Full Width?	N/A
N/A	Landing Curb? (Y/N)	N/A	N/A	DWS Offset (in)	N/A
N/A	Shared Landing?	N/A			
N/A	Gutter Ponding?	N/A	N/A	Gutter Slope (%)	N/A
N/A	Gutter Lip Ht (in)	N/A	N/A	Gutter X Slope (%)	N/A
N/A	Painted X Walk1?	No	N/A	Painted X Walk2?	N/A
	X Walk 1 Direction	To N		X Walk 2 Direction	N/A
N/A	X Walk 1 Width (in)	N/A	N/A	X Walk 2 Width (in)	N/A
	X Walk 1 Slope (%)	0.4		X Walk 2 Slope (%)	N/A
	X Walk 1 X Slope (%)	4.6		X Walk 2 X Slope (%)	N/A

N/A	Ramp inside XWalk1?	N/A	N/A	Ramp inside XWalk2?	N/A
	Road Slope (%)	N/A	N/A	Clear Space?	N/A
	Road X Slope (%)	N/A	N/A	Clear Space to XWalk (in)	N/A
N/A	Any Obstructions?	N/A	N/A	Storm Grate/Utility Hazard?	N/A
	Obstruction Type			Storm Grate/Utility Type	
		N/A			N/A
		Yes		Surface Condition? (G/P)	Good

Remove & Replace Entire Ramp.
