# Access Compliance Report

## Public Rights-of-Way

### (Curb Ramps)

| Intersection ID: 2903 | Main Street: FOGGY_MEADOW_RD | Cross Street: RED_CLOVER_LN | Location: NW |

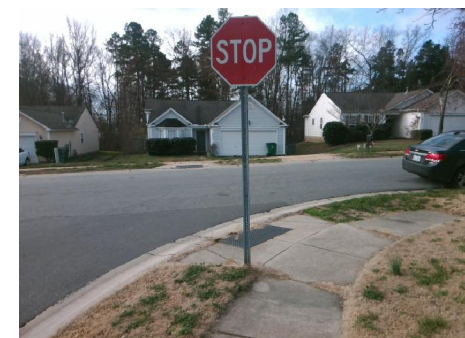
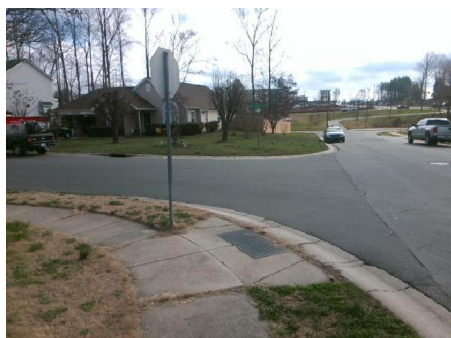
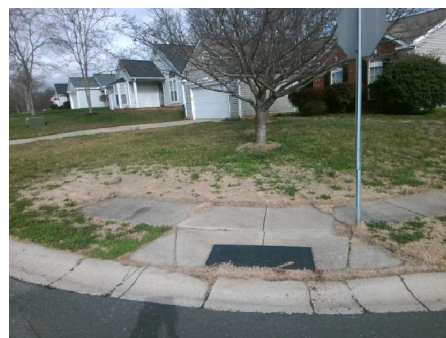
**Not Found, R304.2.1, R304.5.3, R305.2**

| Compliance | Description | Data | Compliance | Description | Data |
|---|---|---|---|---|---|
| No | Landing Length (in) | 47.0 | Yes | DWS Provided? | Yes |
| No | Landing X Slope (%) | 3.7 | Yes | DWS Full Width? | Yes |
| N/A | Landing Curb? (Y/N) | No | No | DWS Offset (in) | 3.0 |
| Yes | Gutter Lip Ht (in) | 0.0 | No | Gutter X Slope (%) | 3.8 |
| | | | No | Curb Slope (%) | 11.2 |

**Remove & Replace Curb Ramp With Two New Directional Ramps or Equivalent. Remove & Replace Gutter.**
