Access Compliance Report

Public Rights-of-Way

(Curb Ramps)

Intersection ID: N/A	Main Street: CLANTON_RD	Cross Street: N/A	Location: W
ADA ID: F5CA9E83C279	Ramp Type: Perp	Initial Pass/Fail: Pass	Overall Compliance: Yes
Codes/Mitigation Info/Possible Solution		Field Measurements/Component Compliance	
		Severity Score: 0

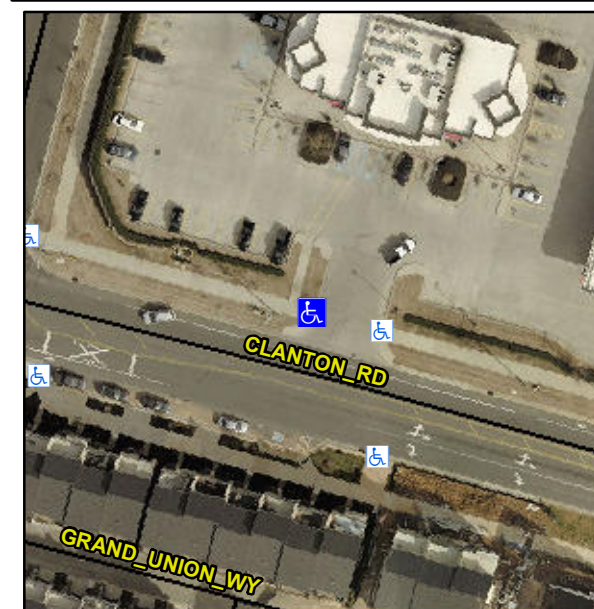
Compliance	Description	Data	Compliance	Description	Data
N/A	Ramp Length (in)	114.0	Yes	Ramp Slope (%)	5.9
Yes	Ramp Width (in)	95.0	Yes	Ramp XSlope (%)	0.4
N/A	Flare Type LT	Sloped	N/A	Flare Type RT	N/A
N/A	Flare Slope LT (%)	3.0	N/A	Flare Slope RT (%)	N/A
N/A	Flare Traversable LT?	Yes	N/A	Flare Traversable RT?	N/A
Yes	Landing Length (in)	60.0	Yes	DWS Provided?	Yes
Yes	Landing Width (in)	96.0	Yes	DWS Contrast?	Yes
Yes	Landing Slope (%)	0.4	Yes	DWS Length (in)	24.0
Yes	Landing X Slope (%)	1.4	Yes	DWS Full Width?	Yes
N/A	Landing Curb? (Y/N)	No	Yes	DWS Offset (in)	0.0
N/A	Shared Landing?	No			
Yes	Gutter Ponding?	No	Yes	Gutter Slope (%)	0.7
Yes	Gutter Lip Ht (in)	0.0	Yes	Gutter X Slope (%)	1.1
N/A	Painted X Walk1?	No	N/A	Painted X Walk2?	N/A
	X Walk 1 Direction	To SE		X Walk 2 Direction	N/A
N/A	X Walk 1 Width (in)	N/A	N/A	X Walk 2 Width (in)	N/A
	X Walk 1 Slope (%)	2.3		X Walk 2 Slope (%)	N/A
	X Walk 1 X Slope (%)	1.8		X Walk 2 X Slope (%)	N/A

N/A	Ramp inside XWalk1?	N/A	N/A	Ramp inside XWalk2?	N/A
	Road Slope (%)	N/A	N/A	Clear Space?	Yes
	Road X Slope (%)	N/A	N/A	Clear Space to XWalk (in)	N/A
Yes	Any Obstructions?	No	Yes	Storm Grate/Utility Hazard?	No
	Obstruction Type			Storm Grate/Utility Type	
		N/A			N/A
			Yes	Surface Condition? (G/P)	Good

Possible Solutions:

N/A
