Access Compliance Report

Public Rights-of-Way

(Curb Ramps)

Intersection ID: 31747	Main Street: LEAF_PLUM_DR	Cross Street: WASHOE_PINE_LN	Location: NE
ADA ID: F5DD0C876EE7	Ramp Type: PerpDiag	Initial Pass/Fail: Fail	Overall Compliance: No
			Severity Score: 21.25

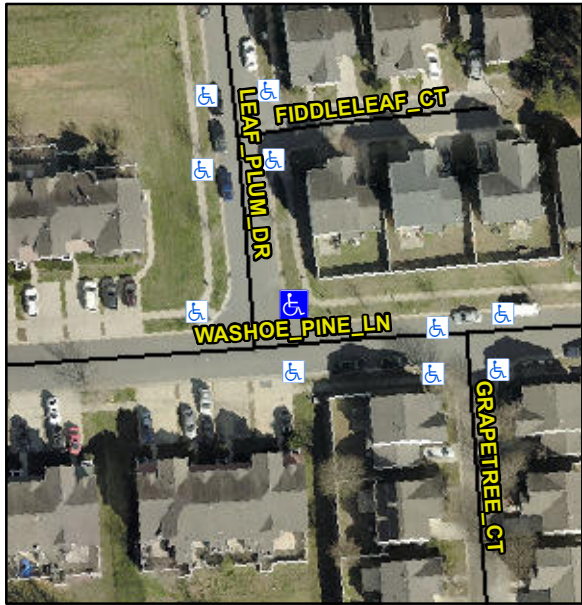
Possible Solutions:		Compliance	Description	Data	Compliance	Description	Data
	Remove & Replace Curb Ramp With Two New Directional Ramps or Equivalent.		N/A	Ramp Length (in)	89.0	No	Ramp Slope (%)	9.0
			No	Ramp Width (in)	45.5	Yes	Ramp XSlope (%)	1.8
			N/A	Flare Type LT	N/A	N/A	Flare Type RT	N/A
			N/A	Flare Slope LT (%)	N/A	N/A	Flare Slope RT (%)	N/A
			N/A	Flare Traversable LT?	N/A	N/A	Flare Traversable RT?	N/A
			N/A	Landing Length (in)	N/A	N/A	DWS Provided?	N/A
			N/A	Landing Width (in)	N/A	N/A	DWS Contrast?	N/A
			N/A	Landing Slope (%)	N/A	N/A	DWS Length (in)	N/A
			N/A	Landing X Slope (%)	N/A	N/A	DWS Full Width?	N/A
Street 1 NameLEAF PLUM DR Stop Condition-Street 2StopSign Street 2 NameWASHOE PINE LN Stop Condition-Street 1None	Surveyor Notes: N/A		N/A	Landing Curb? (Y/N)	N/A	N/A	DWS Offset (in)	N/A
	PROW/ADA: Not Found, R304.5.1, R304.2.2		N/A	Shared Landing?	N/A

N/A	Gutter Ponding?	N/A	N/A	Gutter Slope (%)	N/A
			N/A	Gutter Lip Ht (in)	N/A	N/A	Gutter X Slope (%)	N/A
			N/A	Painted X Walk1?	No	N/A	Painted X Walk2?	No
				X Walk 1 Direction	To W		X Walk 2 Direction	To S
			N/A	X Walk 1 Width (in)	N/A	N/A	X Walk 2 Width (in)	N/A
				X Walk 1 Slope (%)	7.7		X Walk 2 Slope (%)	0.3
				X Walk 1 X Slope (%)	0.8		X Walk 2 X Slope (%)	7.6
			N/A	Ramp inside XWalk1?	N/A	N/A	Ramp inside XWalk2?	N/A
			Road Slope (%)	3.1	N/A	Clear Space?	N/A	
			Road X Slope (%)	7.0	N/A	Clear Space to XWalk (in)	N/A	
		N/A	Any Obstructions?	N/A	N/A	Storm Grate/Utility Hazard?	N/A	
			Obstruction Type			Storm Grate/Utility Type		
					N/A			N/A
						Yes	Surface Condition? (G/P)	Good
Total Cost:		\$ 3200.00
