## **Access Compliance Report Public Rights-of-Way** (Curb Ramps)

Intersection ID: 27270 Main Street: ELMSTONE DR **Cross Street: SUMMITT TREE CT** Location: NW ADA ID: F5EB3B08065C Ramp Type: PerpDiag Initial Pass/Fail: Fail **Overall Compliance: No Severity Score:** 37.5

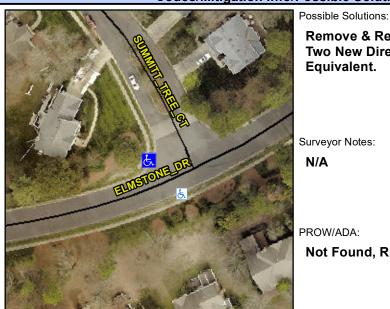
Not Found, R304.2.2, R304.5.3

Compliance Description Data		Data	Compliance Description		Data
N/A	Ramp Length (in)	46.0	No	Ramp Slope (%)	12.2
Yes	Ramp Width (in)	48.0	No	Ramp XSlope (%)	6.0
N/A	Flare Type LT	N/A	N/A	Flare Type RT	N/A
N/A	Flare Slope LT (%)	N/A	N/A	Flare Slope RT (%)	N/A
N/A	Flare Traversable LT?	N/A	N/A	Flare Traversable RT?	N/A
N/A	Landing Length (in)	N/A	N/A	DWS Provided?	N/A
N/A	Landing Width (in)	N/A	N/A	DWS Contrast?	N/A
N/A	Landing Slope (%)	N/A	N/A	DWS Length (in)	N/A
N/A	Landing X Slope (%)	N/A	N/A	DWS Full Width?	N/A
N/A	Landing Curb? (Y/N)	N/A	N/A	DWS Offset (in)	N/A
N/A	Shared Landing?	N/A			
N/A	Gutter Ponding?	N/A	N/A	Gutter Slope (%)	N/A
N/A	Gutter Lip Ht (in)	N/A	N/A	Gutter X Slope (%)	N/A
N/A	Painted X Walk1?	No	N/A	Painted X Walk2?	No
	X Walk 1 Direction	To SE		X Walk 2 Direction	To NE
N/A	X Walk 1 Width (in)	N/A	N/A	X Walk 2 Width (in)	N/A
	X Walk 1 Slope (%)	3.9		X Walk 2 Slope (%)	9.7
	X Walk 1 X Slope (%)	6.2		X Walk 2 X Slope (%)	1.0

N/A	Ramp inside XWalk1?	N/A	N/A	Ramp inside XWalk2?	N/A
	Road Slope (%)	6.0	N/A	Clear Space?	N/A
	Road X Slope (%)	9.0	N/A	Clear Space to XWalk (in)	N/A
N/A	Any Obstructions?	N/A	N/A	Storm Grate/Utility Hazard?	N/A
	Obstruction Type		l	Storm Grate/Utility Type	
		N/A			N/A

**ELMSTONE DR** None **SUMMIT TREE CT** StopSign **Remove & Replace Curb Ramp With Two New Directional Ramps or** Equivalent.
