Access Compliance Report

Public Rights-of-Way

(Curb Ramps)

Intersection ID: 52118	Main Street: REAMES_RD	Cross Street: LONGVIEW_CLUB_LN	Location:	N
ADA ID: F5EF3F35A24E	Ramp Type: Perp	Initial Pass/Fail: Pass	Overall Compliance: No	Severity Score: 0

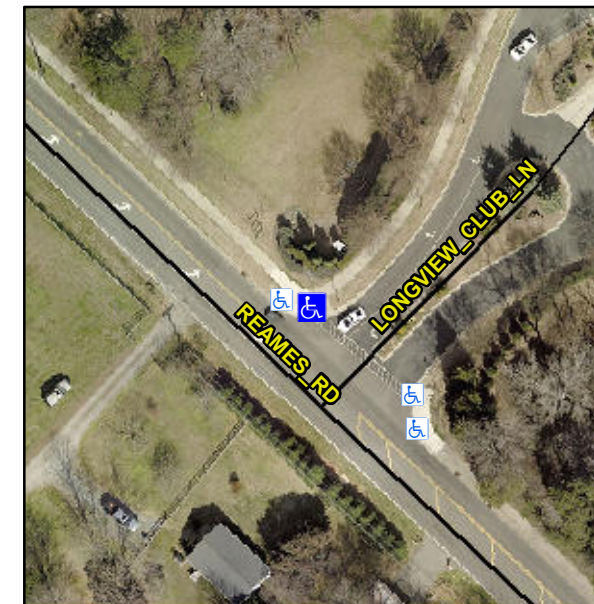
Compliance	Description	Data	Compliance	Description	Data
N/A	Ramp Length (in)	87.5	Yes	Ramp Slope (%)	7.5
Yes	Ramp Width (in)	48.0	Yes	Ramp XSlope (%)	0.5
N/A	Flare Type LT	Sloped	N/A	Flare Type RT	N/A
N/A	Flare Slope LT (%)	7.0	Yes	Flare Slope RT (%)	6.4
N/A	Flare Traversable LT?	Yes	N/A	Flare Traversable RT?	Yes
Yes	Landing Length (in)	72.0	Yes	DWS Provided?	Yes
Yes	Landing Width (in)	48.0	Yes	DWS Contrast?	Yes
Yes	Landing Slope (%)	0.1	Yes	DWS Length (in)	24.0
Yes	Landing X Slope (%)	0.3	Yes	DWS Full Width?	Yes
N/A	Landing Curb? (Y/N)	No	No	DWS Offset (in)	2.5
N/A	Shared Landing?	No			
Yes	Gutter Ponding?	No	Yes	Gutter Slope (%)	1.4
Yes	Gutter Lip Ht (in)	0.0	Yes	Gutter X Slope (%)	0.0
N/A	Painted X Walk1?	Yes	N/A	Painted X Walk2?	N/A
	X Walk 1 Direction	To S		X Walk 2 Direction	N/A
N/A	X Walk 1 Width (in)	60.0	N/A	X Walk 2 Width (in)	N/A
	X Walk 1 Slope (%)	3.3		X Walk 2 Slope (%)	N/A
	X Walk 1 X Slope (%)	3.0		X Walk 2 X Slope (%)	N/A

Yes	Ramp inside XWalk1?	Yes	N/A	Ramp inside XWalk2?	N/A
	Road Slope (%)	N/A	N/A	Clear Space?	Yes
	Road X Slope (%)	N/A	N/A	Clear Space to XWalk (in)	N/A
Yes	Any Obstructions?	No	Yes	Storm Grate/Utility Hazard?	No
	Obstruction Type			Storm Grate/Utility Type	
		N/A			N/A
			Yes	Surface Condition? (G/P)	Good

Possible Solutions:

Remove & Replace Detectable Warning System.

R305.2

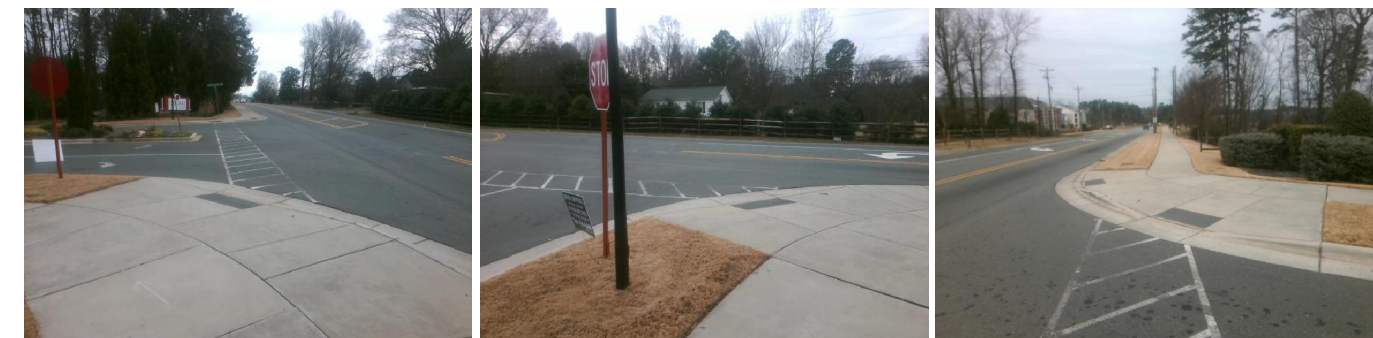
Street 1 Name LONGVIEW CLUB LN
 Stop Condition-Street 2 StopSign
 Street 2 Name N/A
 Stop Condition-Street 1 N/A
