Access Compliance Report

Public Rights-of-Way

(Curb Ramps)

Intersection ID: 49320	Main Street: TAVISTOCK_CT	Cross Street: HUNTERS_MOON_LN	Location: SE
ADA ID: F5F5DC0CA54B	Ramp Type: Perp	Initial Pass/Fail: Fail	Overall Compliance: No Severity Score: 13.75

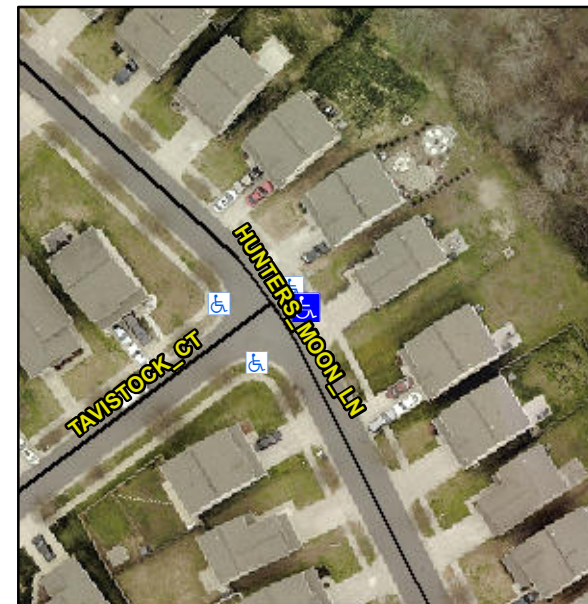
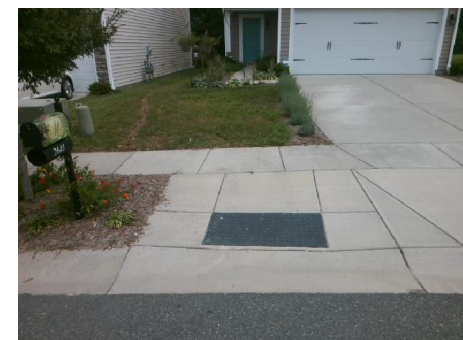
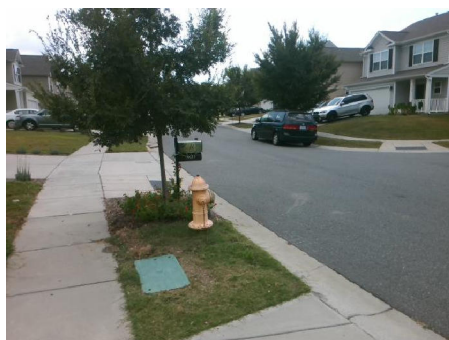
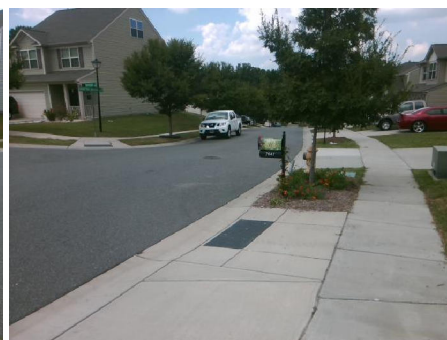
Compliance	Description	Data	Compliance	Description	Data
N/A	Ramp Length (in)	69.0	No	Ramp Slope (%)	10.1
Yes	Ramp Width (in)	48.0	Yes	Ramp XSlope (%)	2.3
N/A	Flare Type LT	N/A	N/A	Flare Type RT	N/A
N/A	Flare Slope LT (%)	N/A	N/A	Flare Slope RT (%)	N/A
N/A	Flare Traversable LT?	N/A	N/A	Flare Traversable RT?	N/A
N/A	Landing Length (in)	N/A	N/A	DWS Provided?	N/A
N/A	Landing Width (in)	N/A	N/A	DWS Contrast?	N/A
N/A	Landing Slope (%)	N/A	N/A	DWS Length (in)	N/A
N/A	Landing X Slope (%)	N/A	N/A	DWS Full Width?	N/A
N/A	Landing Curb? (Y/N)	N/A	N/A	DWS Offset (in)	N/A
N/A	Shared Landing?	N/A			
N/A	Gutter Ponding?	N/A	N/A	Gutter Slope (%)	N/A
N/A	Gutter Lip Ht (in)	N/A	N/A	Gutter X Slope (%)	N/A
N/A	Painted X Walk1?	No	N/A	Painted X Walk2?	N/A
	X Walk 1 Direction	To SW		X Walk 2 Direction	N/A
N/A	X Walk 1 Width (in)	N/A	N/A	X Walk 2 Width (in)	N/A
	X Walk 1 Slope (%)	2.3		X Walk 2 Slope (%)	N/A
	X Walk 1 X Slope (%)	3.5		X Walk 2 X Slope (%)	N/A

N/A	Ramp inside XWalk1?	N/A	N/A	Ramp inside XWalk2?	N/A
	Road Slope (%)	N/A	N/A	Clear Space?	N/A
	Road X Slope (%)	N/A	N/A	Clear Space to XWalk (in)	N/A
N/A	Any Obstructions?	N/A	N/A	Storm Grate/Utility Hazard?	N/A
	Obstruction Type			Storm Grate/Utility Type	
		N/A			N/A
			Yes	Surface Condition? (G/P)	Good

Remove & Replace Entire Ramp.

R304.2.2
