# Access Compliance Report

## Public Rights-of-Way

### (Curb Ramps)

Intersection ID: N/A	Main Street: MATTHEWS_FARM_LN	Cross Street: N/A	Location: SE
ADA ID: F6016ABA813E	Ramp Type: Perp	Initial Pass/Fail: Fail	Overall Compliance: No
Codes/Mitigation Info/Possible Solution		Field Measurements/Component Compliance	
Severity Score: 13.75

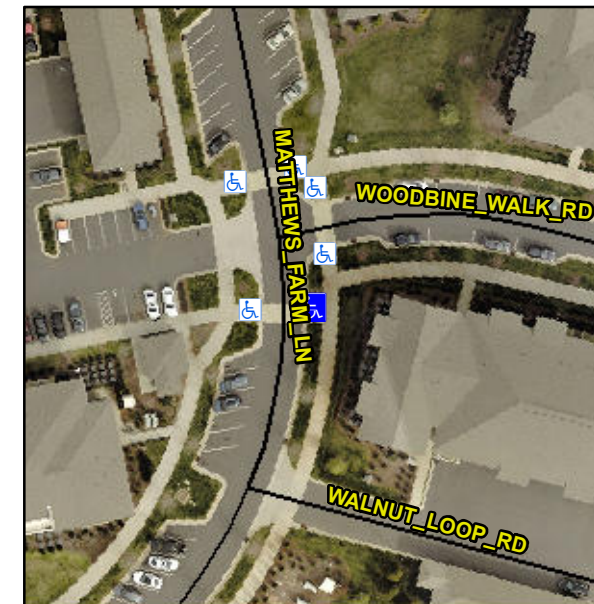
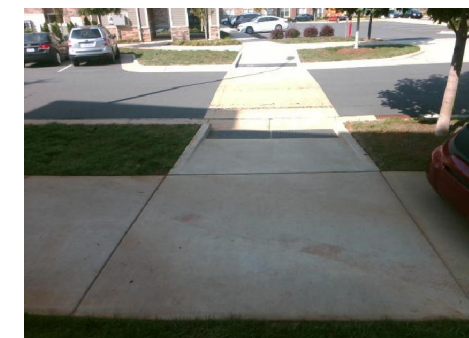
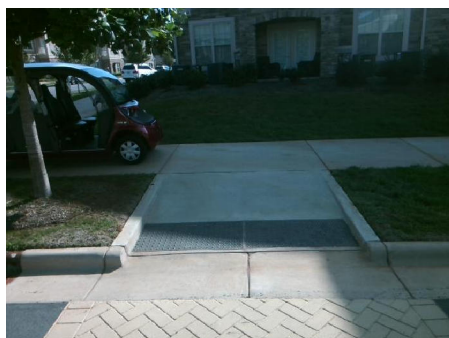
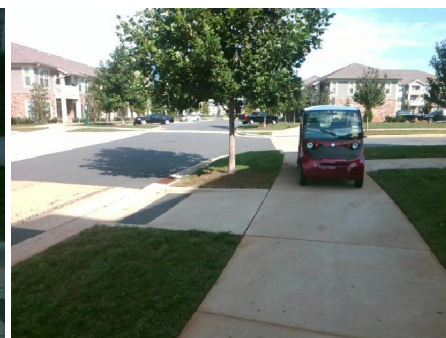
**Not Found, R304.2.2, R304.5.3**

Compliance	Description	Data	Compliance	Description	Data
N/A	Ramp Length (in)	94.0	No	Ramp Slope (%)	9.4
Yes	Ramp Width (in)	99.0	No	Ramp XSlope (%)	3.8
N/A	Flare Type LT	N/A	N/A	Flare Type RT	N/A
N/A	Flare Slope LT (%)	N/A	N/A	Flare Slope RT (%)	N/A
N/A	Flare Traversable LT?	N/A	N/A	Flare Traversable RT?	N/A
N/A	Landing Length (in)	N/A	N/A	DWS Provided?	N/A
N/A	Landing Width (in)	N/A	N/A	DWS Contrast?	N/A
N/A	Landing Slope (%)	N/A	N/A	DWS Length (in)	N/A
N/A	Landing X Slope (%)	N/A	N/A	DWS Full Width?	N/A
N/A	Landing Curb? (Y/N)	N/A	N/A	DWS Offset (in)	N/A
N/A	Shared Landing?	N/A			
N/A	Gutter Ponding?	N/A	N/A	Gutter Slope (%)	N/A
N/A	Gutter Lip Ht (in)	N/A	N/A	Gutter X Slope (%)	N/A
N/A	Painted X Walk1?	No	N/A	Painted X Walk2?	N/A
	X Walk 1 Direction	To W		X Walk 2 Direction	N/A
N/A	X Walk 1 Width (in)	N/A	N/A	X Walk 2 Width (in)	N/A
	X Walk 1 Slope (%)	2.2		X Walk 2 Slope (%)	N/A
	X Walk 1 X Slope (%)	2.4		X Walk 2 X Slope (%)	N/A

N/A	Ramp inside XWalk1?	N/A	N/A	Ramp inside XWalk2?	N/A
	Road Slope (%)	N/A	N/A	Clear Space?	N/A
	Road X Slope (%)	N/A	N/A	Clear Space to XWalk (in)	N/A
N/A	Any Obstructions?	N/A	N/A	Storm Grate/Utility Hazard?	N/A
	Obstruction Type			Storm Grate/Utility Type	
		N/A			N/A
			Yes	Surface Condition? (G/P)	Good

**Remove & Replace Entire Ramp.**

Total Cost: \$ 1850.00
