Access Compliance Report Public Rights-of-Way (Curb Ramps)

| Intersection ID: 12036 Main St | rsection ID: 12036 Main Street: W_MOREHEAD_ST | | Cross Street: CALVERT_ST | | | | NE |
| ADA ID: F605F62BC32D Ramp Type: Perp | | Initial Pass/Fail: Fail Overall Compliance: No | | | | o Severity Score: | 10 |

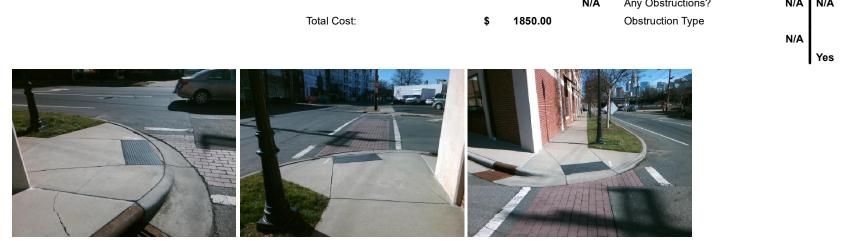
| Intersection ID: 12036 Main St | rsection ID: 12036 Main Street: W_MOREHEAD_ST | | Cross Street: CALVERT_ST | | | | NE |
|---|---|--|---|---|---|---|---|
| | Remove & Replace Entire Ramp. | N/A | Ramp Lengt | th (in) 88.0 | Yes | Ramp Slope (%) | 5.3 |
| | | No | Ramp Width | · · / | No | Ramp XSlope (%) | 3.9 |
| | Not Found, R304.5.1, R304.5.3 | N/A | Gutter Lip H | - | N/A | Gutter X Slope (%) | N/A |

| Intersection ID: 12036 Main St | rsection ID: 12036 Main Street: W_MOREHEAD_ST | | Cross Street: CALVERT_ST | | | | NE |
|---|---|--|---|---|---|---|---|
| | Total Cost: \$ 1 | 850.00 | Obstruction | | | Storm Grate/Utility Type | |
