Access Compliance Report

Public Rights-of-Way

(Curb Ramps)

Intersection ID: 27772	Main Street: BRIARWICK_LN	Cross Street: NORTH_COMMUNITY_HOUSE_RD	Location: NE
ADA ID: F60815098A12	Ramp Type: Perp	Initial Pass/Fail: Fail	Overall Compliance: No
Codes/Mitigation Info/Possible Solution		Field Measurements/Component Compliance	
Severity Score: 22.5

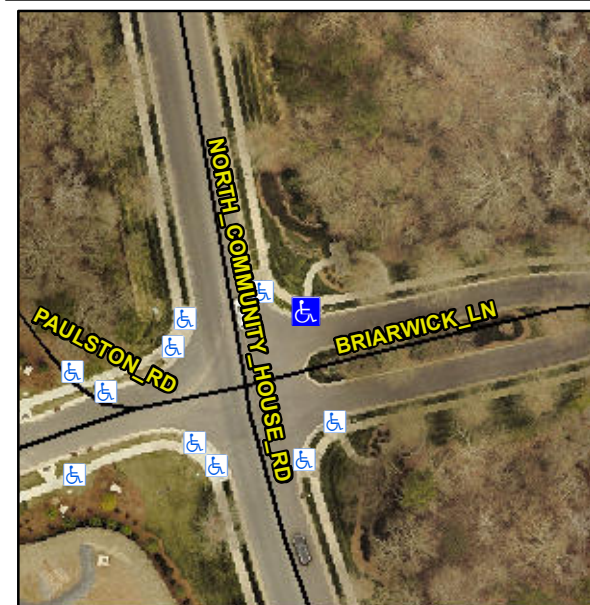
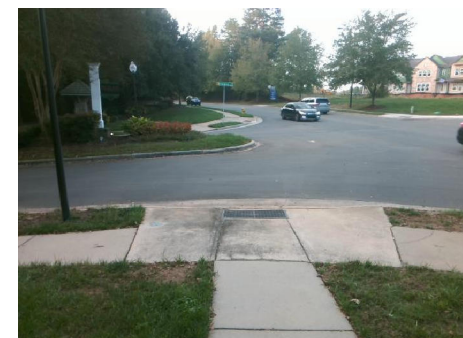
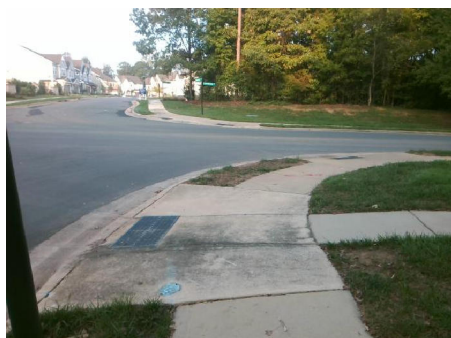
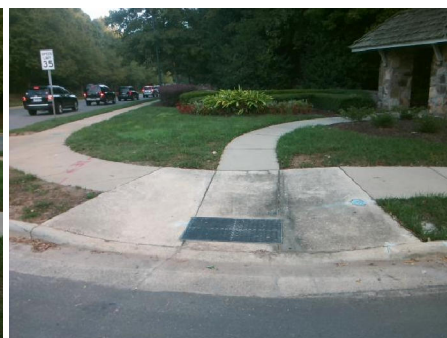
Not Found, R304.5.1, R304.2.2, R304.5.3

Compliance	Description	Data	Compliance	Description	Data
N/A	Ramp Length (in)	108.0	No	Ramp Slope (%)	8.5
No	Ramp Width (in)	43.5	No	Ramp XSlope (%)	2.1
N/A	Flare Type LT	N/A	N/A	Flare Type RT	N/A
N/A	Flare Slope LT (%)	N/A	N/A	Flare Slope RT (%)	N/A
N/A	Flare Traversable LT?	N/A	N/A	Flare Traversable RT?	N/A
N/A	Landing Length (in)	N/A	N/A	DWS Provided?	N/A
N/A	Landing Width (in)	N/A	N/A	DWS Contrast?	N/A
N/A	Landing Slope (%)	N/A	N/A	DWS Length (in)	N/A
N/A	Landing X Slope (%)	N/A	N/A	DWS Full Width?	N/A
N/A	Landing Curb? (Y/N)	N/A	N/A	DWS Offset (in)	N/A
N/A	Shared Landing?	N/A			
N/A	Gutter Ponding?	N/A	N/A	Gutter Slope (%)	N/A
N/A	Gutter Lip Ht (in)	N/A	N/A	Gutter X Slope (%)	N/A
N/A	Painted X Walk1?	No	N/A	Painted X Walk2?	N/A
	X Walk 1 Direction	To S		X Walk 2 Direction	N/A
N/A	X Walk 1 Width (in)	N/A	N/A	X Walk 2 Width (in)	N/A
	X Walk 1 Slope (%)	8.1		X Walk 2 Slope (%)	N/A
	X Walk 1 X Slope (%)	2.9		X Walk 2 X Slope (%)	N/A

N/A	Ramp inside XWalk1?	N/A	N/A	Ramp inside XWalk2?	N/A
	Road Slope (%)	N/A	N/A	Clear Space?	N/A
	Road X Slope (%)	N/A	N/A	Clear Space to XWalk (in)	N/A
N/A	Any Obstructions?	N/A	N/A	Storm Grate/Utility Hazard?	N/A
	Obstruction Type			Storm Grate/Utility Type	
		N/A			N/A
			Yes	Surface Condition? (G/P)	Good

Possible Solutions:

Remove & Replace Entire Ramp.
