## **Access Compliance Report Public Rights-of-Way** (Curb Ramps)

Cross Street: N/A Intersection ID: 10025513 Main Street: E\_MOREHEAD\_ST Location: W **Overall Compliance: No** ADA ID: F61236FBF341 Ramp Type: Directional1 Initial Pass/Fail: Fail Severity Score: 33.75

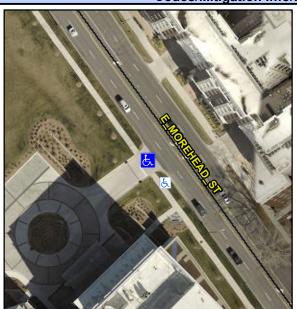
Comp	liance Description	Data	Comp	liance Description	Data
N/A	Ramp Length (in)	56.0	N/A	Grade Break?	N/A
No	Ramp Width (in)	47.0	N/A	Grade Break Slope (%)	0.0
Yes	Ramp Slope (%)	5.3	N/A	Grade Break XSlope (%)	0.0
No	Ramp XSlope (%)	8.1			
N/A	Flare Type LT	N/A	N/A	Flare Type RT	N/A
N/A	Flare Slope LT (%)	N/A	N/A	Flare Slope RT (%)	0.0
N/A	Flare Traversable LT?	N/A	N/A	Flare Traversable RT?	N/A
N/A	Landing Length (in)	0.0	N/A	DWS Provided?	N/A
N/A	Landing Width (in)	0.0	N/A	DWS Contrast?	N/A
N/A	Landing Slope (%)	0.0	N/A	DWS Length (in)	N/A
N/A	Landing X Slope (%)	0.0	N/A	DWS Full Width?	N/A
N/A	Landing Curb? (Y/N)	N/A	N/A	DWS Offset LT (in)	N/A
N/A	Shared Landing?	N/A	N/A	DWS Offset RT (in)	N/A
N/A	Gutter Ponding?	0.0	N/A	Gutter Slope (%)	N/A
N/A	Gutter Lip Ht (in)	0.0	N/A	Gutter X Slope (%)	N/A
N/A	Painted X Walk1?	No		Road Slope (%)	5.4
	X Walk 1 Direction	To SE		Road X Slope (%)	5.
	X Walk 1 Width (in)	N/A		Clear Space?	N/A

X Walk 1 Slope (%)	5.4	N/A	Clear Space to XWalk (in)	N/A
	X Walk 1 X Slope (%)	5.1	N/A	Storm Grate/Utility Hazard?	N/A
N/A	Ramp inside XWalk1?	N/A		Storm Grate/Utility Type	
N/A	Any Obstructions?	N/A			N/A
	Obstruction Type		Yes	Surface Condition? (G/P)	Good
		N/A	N/A	Curb Slope (%)	3.0

Possible Solutions:	Cor
Remove & Replace Entire Ramp.	N/A
·	No
	Yes
	No
	N/A
	N/A
Surveyor Notes:	N/A
N/A	N/A
	N/A
	N/A
	N/A
PROW/ADA:	N/A
R304.5.1, R304.5.3	N/A
	N/A
	N/A
	N/A

IN/
		N/
PROW/ADA:		N/
R304.5.1, R304.5.3		N/
		N/
		N/
Total Cost:	\$ 1600.00
