Access Compliance Report Public Rights-of-Way (Curb Ramps)

Intersection ID: 43406 Main St	Cross Street: PARK ROYAL_AV				Location:	SE	
ADA ID: F6184420A7A0 Ramp Type: Perp		Initial Pass/Fail: Fail Overall Compliance: No			o Severity Score:	22.5	
Codes/Mitigation Info/Possible Solution		Field Measurements/Component Compliance					
C STATE AND A SAME AND A SAME AND A SAME	Possible Solutions:	Com	pliance Description	Data	Comp	liance Description	Data
	Remove & Replace Entire Ramp.	N/A	Ramp Length (in)	142.0	No	Ramp Slope (%)	10.6
		No	Ramp Width (in)	38.0	Yes	Ramp XSlope (%)	2.2
alling the same the	5	N/A	Flare Type LT	N/A	N/A	Flare Type RT	N/A
<u>6.</u>		N/A	Flare Slope LT (%)	N/A	N/A	Flare Slope RT (%)	N/A
		N/A	Flare Traversable LT?	N/A	N/A	Flare Traversable RT?	N/A
ARCHDALLEDR		N/A	Landing Length (in)	N/A	N/A	DWS Provided?	N/A
	Surveyor Notes:	N/A	Landing Width (in)	N/A	N/A	DWS Contrast?	N/A
	N/A	N/A	Landing Slope (%)	N/A	N/A	DWS Length (in)	N/A
		N/A	Landing X Slope (%)	N/A	N/A	DWS Full Width?	N/A

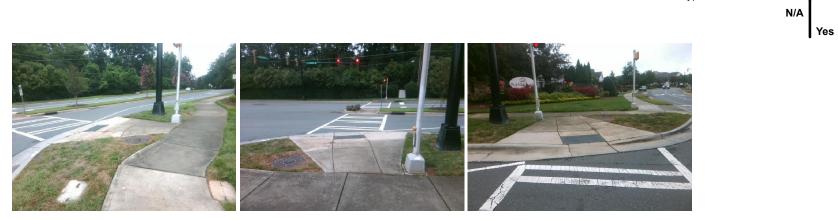
4	N/A	Landing Curb? (Y/N)	N/A	N/A	DWS Offset (in)	N/A
		N/A	Shared Landing?	N/A			
ite of the second secon	PROW/ADA:	N/A	Gutter Ponding?	N/A	N/A	Gutter Slope (%)	N/A
	Not Found, R304.5.1, R304.2.2	N/A	Gutter Lip Ht (in)	N/A	N/A	Gutter X Slope (%)	N/A
		N/A	Painted X Walk1?	Yes	N/A	Painted X Walk2?	N/A
			X Walk 1 Direction	To N		X Walk 2 Direction	N/A
	8	N/A	X Walk 1 Width (in)	115.0	N/A	X Walk 2 Width (in)	N/A
Street 1 Name ARCHDALE DR			X Walk 1 Slope (%)	4.6		X Walk 2 Slope (%)	N/A
Stop Condition-Street 2 Signal			X Walk 1 X Slope (%)	2.4		X Walk 2 X Slope (%)	N/A
Street 2 Name N/A		N/A	Ramp inside XWalk1?	Yes	N/A	Ramp inside XWalk2?	N/A
Stop Condition-Street 1 N/A			Road Slope (%)	N/A	N/A	Clear Space?	N/A
			Road X Slope (%)	N/A	N/A	Clear Space to XWalk (in)	N/A
		N/A	Any Obstructions?	N/A	N/A	Storm Grate/Utility Hazard?	N/A
	Total Cost: \$ 1	850.00	Obstruction Type			Storm Grate/Utility Type	
				N/A			N/A
