# Access Compliance Report

## Public Rights-of-Way

Intersection ID: 43846	Main Street: CURRIER_RD	Cross Street: BRADSTREET_COMMONS_WY	Location: SE
ADA ID: F61B32F31C05	Ramp Type: PerpDiag	Initial Pass/Fail: Fail	Overall Compliance: No
Severity Score: 12.5			
Codes/Mitigation Info/Possible Solution		Field Measurements/Component Compliance

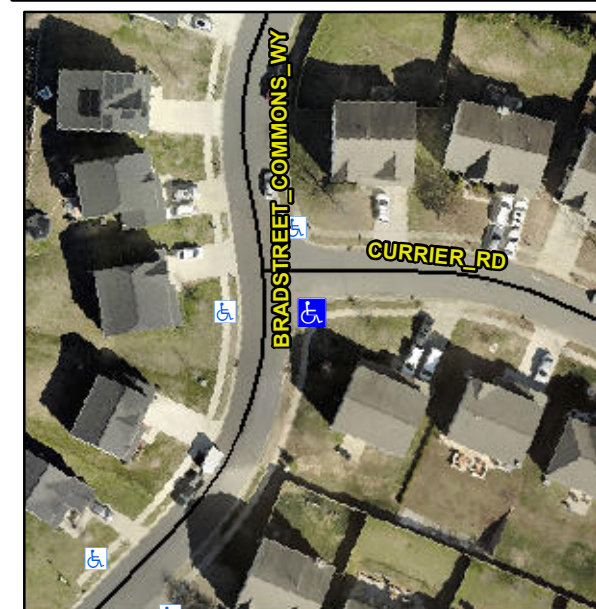
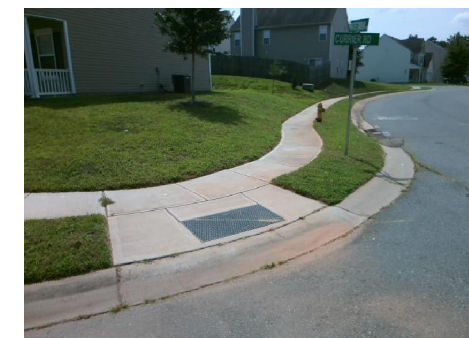
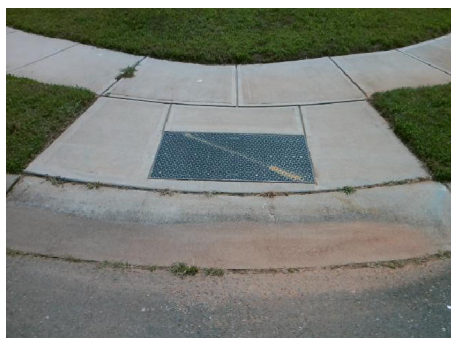
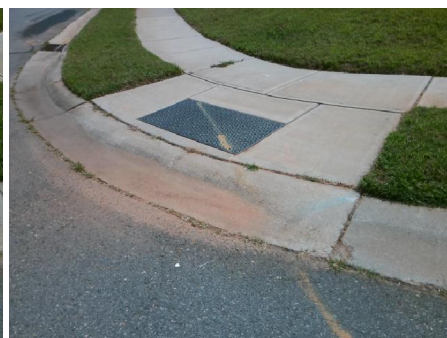
Compliance	Description	Data	Compliance	Description	Data
N/A	Ramp Length (in)	47.0	No	Ramp Slope (%)	9.1
Yes	Ramp Width (in)	48.0	Yes	Ramp XSlope (%)	0.4
N/A	Flare Type LT	N/A	N/A	Flare Type RT	N/A
N/A	Flare Slope LT (%)	N/A	N/A	Flare Slope RT (%)	N/A
N/A	Flare Traversable LT?	N/A	N/A	Flare Traversable RT?	N/A
N/A	Landing Length (in)	N/A	N/A	DWS Provided?	N/A
N/A	Landing Width (in)	N/A	N/A	DWS Contrast?	N/A
N/A	Landing Slope (%)	N/A	N/A	DWS Length (in)	N/A
N/A	Landing X Slope (%)	N/A	N/A	DWS Full Width?	N/A
N/A	Landing Curb? (Y/N)	N/A	N/A	DWS Offset (in)	N/A
N/A	Shared Landing?	N/A			
N/A	Gutter Ponding?	N/A	N/A	Gutter Slope (%)	N/A
N/A	Gutter Lip Ht (in)	N/A	N/A	Gutter X Slope (%)	N/A
N/A	Painted X Walk1?	No	N/A	Painted X Walk2?	No
	X Walk 1 Direction	To N		X Walk 2 Direction	To W
N/A	X Walk 1 Width (in)	N/A	N/A	X Walk 2 Width (in)	N/A
	X Walk 1 Slope (%)	1.1		X Walk 2 Slope (%)	0.6
	X Walk 1 X Slope (%)	1.7		X Walk 2 X Slope (%)	2.2

N/A	Ramp inside XWalk1?	N/A	N/A	Ramp inside XWalk2?	N/A
	Road Slope (%)	0.9	N/A	Clear Space?	N/A
	Road X Slope (%)	0.0	N/A	Clear Space to XWalk (in)	N/A
N/A	Any Obstructions?	N/A	N/A	Storm Grate/Utility Hazard?	N/A
	Obstruction Type			Storm Grate/Utility Type	
		N/A			N/A
		Yes		Surface Condition? (G/P)	Good

**Remove & Replace Curb Ramp With Two New Directional Ramps or Equivalent.**
