Access Compliance Report

Public Rights-of-Way

(Curb Ramps)

Intersection ID: 49507	Main Street: OSCEOLA_LN	Cross Street: ANKENY_CT	Location: S
ADA ID: F61D8D572A6B	Ramp Type: PerpDiag	Initial Pass/Fail: Fail	Overall Compliance: No
Severity Score: 28.75			
Codes/Mitigation Info/Possible Solution		Field Measurements/Component Compliance

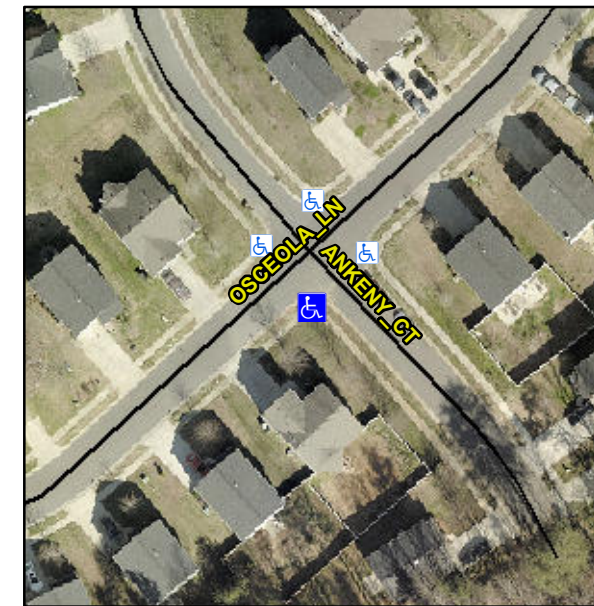
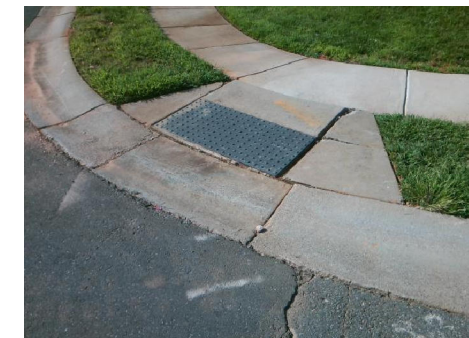
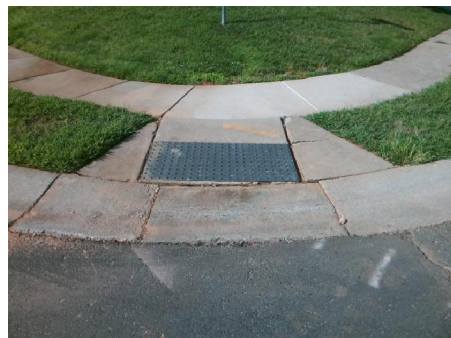
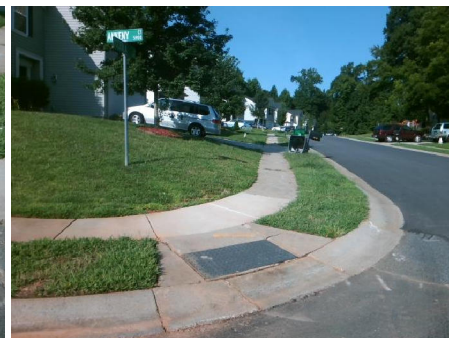
Compliance	Description	Data	Compliance	Description	Data
N/A	Ramp Length (in)	47.0	No	Ramp Slope (%)	11.8
Yes	Ramp Width (in)	48.0	No	Ramp XSlope (%)	2.3
N/A	Flare Type LT	N/A	N/A	Flare Type RT	N/A
N/A	Flare Slope LT (%)	N/A	N/A	Flare Slope RT (%)	N/A
N/A	Flare Traversable LT?	N/A	N/A	Flare Traversable RT?	N/A
N/A	Landing Length (in)	N/A	N/A	DWS Provided?	N/A
N/A	Landing Width (in)	N/A	N/A	DWS Contrast?	N/A
N/A	Landing Slope (%)	N/A	N/A	DWS Length (in)	N/A
N/A	Landing X Slope (%)	N/A	N/A	DWS Full Width?	N/A
N/A	Landing Curb? (Y/N)	N/A	N/A	DWS Offset (in)	N/A
N/A	Shared Landing?	N/A			
N/A	Gutter Ponding?	N/A	N/A	Gutter Slope (%)	N/A
N/A	Gutter Lip Ht (in)	N/A	N/A	Gutter X Slope (%)	N/A
N/A	Painted X Walk1?	No	N/A	Painted X Walk2?	No
	X Walk 1 Direction	To NW		X Walk 2 Direction	To NE
N/A	X Walk 1 Width (in)	N/A	N/A	X Walk 2 Width (in)	N/A
	X Walk 1 Slope (%)	3.2		X Walk 2 Slope (%)	1.8
	X Walk 1 X Slope (%)	3.4		X Walk 2 X Slope (%)	4.2

N/A	Ramp inside XWalk1?	N/A	N/A	Ramp inside XWalk2?	N/A
	Road Slope (%)	3.3	N/A	Clear Space?	N/A
	Road X Slope (%)	3.4	N/A	Clear Space to XWalk (in)	N/A
N/A	Any Obstructions?	N/A	N/A	Storm Grate/Utility Hazard?	N/A
	Obstruction Type			Storm Grate/Utility Type	
		N/A			N/A
		No		Surface Condition? (G/P)	Poor

Possible Solutions:

Remove & Replace Curb Ramp With Two New Directional Ramps or Equivalent.

R304.2.2, R304.5.3, R302.7
