Access Compliance Report

Public Rights-of-Way

(Curb Ramps)

Intersection ID: 46694	Main Street: TROTTERS RIDGE RD	Cross Street: OLD MEADOW RD	Location: SW
ADA ID: F621A3CD0F73	Ramp Type: PerpDiag	Initial Pass/Fail: Fail	Overall Compliance: No
Severity Score: 12.5			
Codes/Mitigation Info/Possible Solution		Field Measurements/Component Compliance

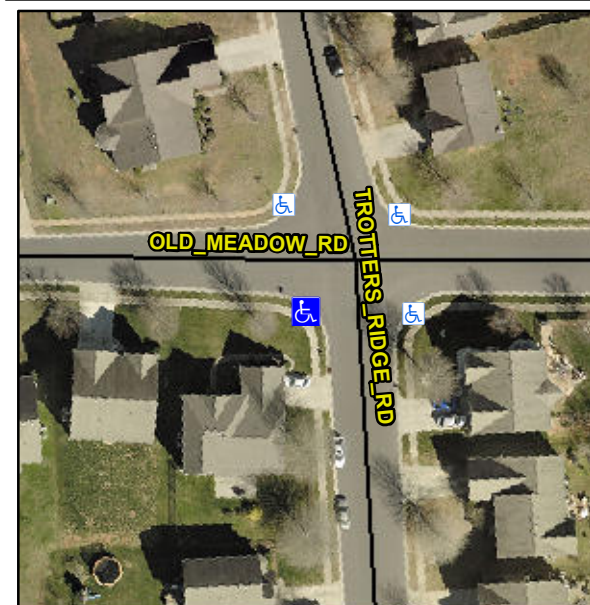
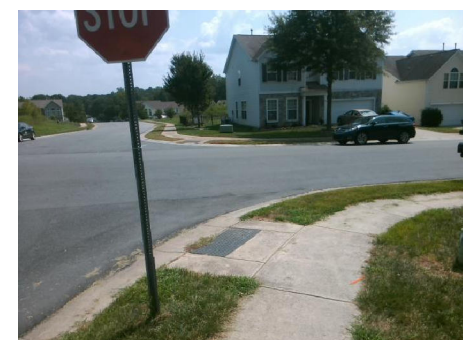
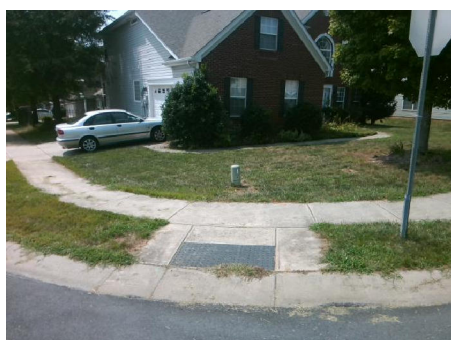
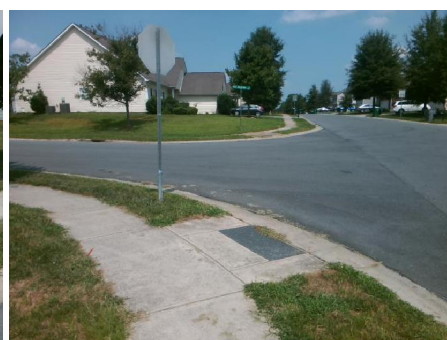
Compliance	Description	Data	Compliance	Description	Data
N/A	Ramp Length (in)	47.0	Yes	Ramp Slope (%)	5.2
Yes	Ramp Width (in)	48.0	No	Ramp XSlope (%)	6.1
N/A	Flare Type LT	N/A	N/A	Flare Type RT	N/A
N/A	Flare Slope LT (%)	N/A	N/A	Flare Slope RT (%)	N/A
N/A	Flare Traversable LT?	N/A	N/A	Flare Traversable RT?	N/A
N/A	Landing Length (in)	N/A	N/A	DWS Provided?	N/A
N/A	Landing Width (in)	N/A	N/A	DWS Contrast?	N/A
N/A	Landing Slope (%)	N/A	N/A	DWS Length (in)	N/A
N/A	Landing X Slope (%)	N/A	N/A	DWS Full Width?	N/A
N/A	Landing Curb? (Y/N)	N/A	N/A	DWS Offset (in)	N/A
N/A	Shared Landing?	N/A			
N/A	Gutter Ponding?	N/A	N/A	Gutter Slope (%)	N/A
N/A	Gutter Lip Ht (in)	N/A	N/A	Gutter X Slope (%)	N/A
N/A	Painted X Walk1?	No	N/A	Painted X Walk2?	No
	X Walk 1 Direction	To E		X Walk 2 Direction	To N
N/A	X Walk 1 Width (in)	N/A	N/A	X Walk 2 Width (in)	N/A
	X Walk 1 Slope (%)	3.0		X Walk 2 Slope (%)	7.2
	X Walk 1 X Slope (%)	5.2		X Walk 2 X Slope (%)	0.9

N/A	Ramp inside XWalk1?	N/A	N/A	Ramp inside XWalk2?	N/A
	Road Slope (%)	2.6	N/A	Clear Space?	N/A
	Road X Slope (%)	5.2	N/A	Clear Space to XWalk (in)	N/A
N/A	Any Obstructions?	N/A	N/A	Storm Grate/Utility Hazard?	N/A
	Obstruction Type			Storm Grate/Utility Type	
		N/A			N/A
			Yes	Surface Condition? (G/P)	Good

Possible Solutions:

Remove & Replace Curb Ramp With Two New Directional Ramps or Equivalent.
