# Access Compliance Report

## Public Rights-of-Way

### (Curb Ramps)

Intersection ID: N/A	Main Street: PINEVILLE-MATTHEWS_RD	Cross Street: N/A	Location: NE
ADA ID: F6230CCD7780	Ramp Type: PerpDiag	Initial Pass/Fail: Fail	Overall Compliance: No
			Severity Score: 33.75

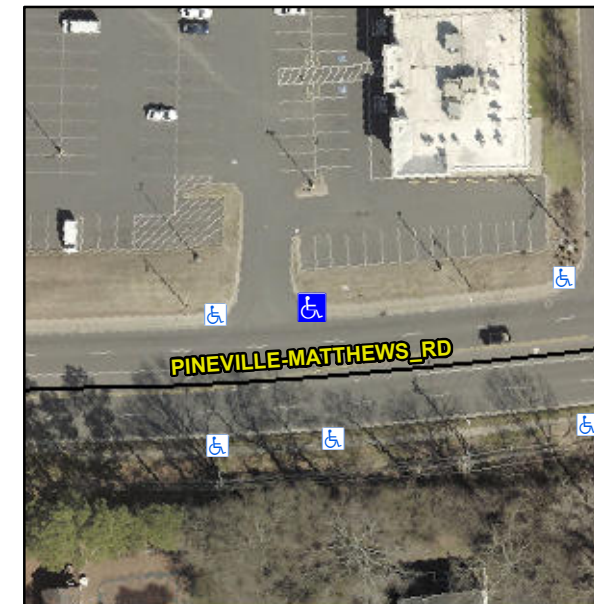
**Not Found, R304.5.1, R304.2.2, R304.5.3**

Compliance	Description	Data	Compliance	Description	Data
N/A	Ramp Length (in)	59.0	No	Ramp Slope (%)	9.9
No	Ramp Width (in)	40.0	No	Ramp XSlope (%)	6.2
N/A	Flare Type LT	N/A	N/A	Flare Type RT	N/A
N/A	Flare Slope LT (%)	N/A	N/A	Flare Slope RT (%)	N/A
N/A	Flare Traversable LT?	N/A	N/A	Flare Traversable RT?	N/A
N/A	Landing Length (in)	N/A	N/A	DWS Provided?	N/A
N/A	Landing Width (in)	N/A	N/A	DWS Contrast?	N/A
N/A	Landing Slope (%)	N/A	N/A	DWS Length (in)	N/A
N/A	Landing X Slope (%)	N/A	N/A	DWS Full Width?	N/A
N/A	Landing Curb? (Y/N)	N/A	N/A	DWS Offset (in)	N/A
N/A	Shared Landing?	N/A			
N/A	Gutter Ponding?	N/A	N/A	Gutter Slope (%)	N/A
N/A	Gutter Lip Ht (in)	N/A	N/A	Gutter X Slope (%)	N/A
N/A	Painted X Walk1?	No	N/A	Painted X Walk2?	No
	X Walk 1 Direction	To W		X Walk 2 Direction	To S
N/A	X Walk 1 Width (in)	N/A	N/A	X Walk 2 Width (in)	N/A
	X Walk 1 Slope (%)	4.2		X Walk 2 Slope (%)	1.8
	X Walk 1 X Slope (%)	1.9		X Walk 2 X Slope (%)	4.2

N/A	Ramp inside XWalk1?	N/A	N/A	Ramp inside XWalk2?	N/A
	Road Slope (%)	4.2	N/A	Clear Space?	N/A
	Road X Slope (%)	1.6	N/A	Clear Space to XWalk (in)	N/A
N/A	Any Obstructions?	N/A	N/A	Storm Grate/Utility Hazard?	N/A
	Obstruction Type			Storm Grate/Utility Type	
		N/A			N/A
			Yes	Surface Condition? (G/P)	Good

**Remove & Replace Curb Ramp With Two New Directional Ramps or Equivalent.**

Total Cost: \$ 3200.00
