Access Compliance Report

Public Rights-of-Way

(Curb Ramps)

Intersection ID: 50449	Main Street: MAGNOLIA_WOODS_LN	Cross Street: MARLEY_WALK_LN	Location: SE
ADA ID: F633FC416397	Ramp Type: PerpDiag	Initial Pass/Fail: Fail	Overall Compliance: No
Severity Score: 13.75			
Codes/Mitigation Info/Possible Solution		Field Measurements/Component Compliance

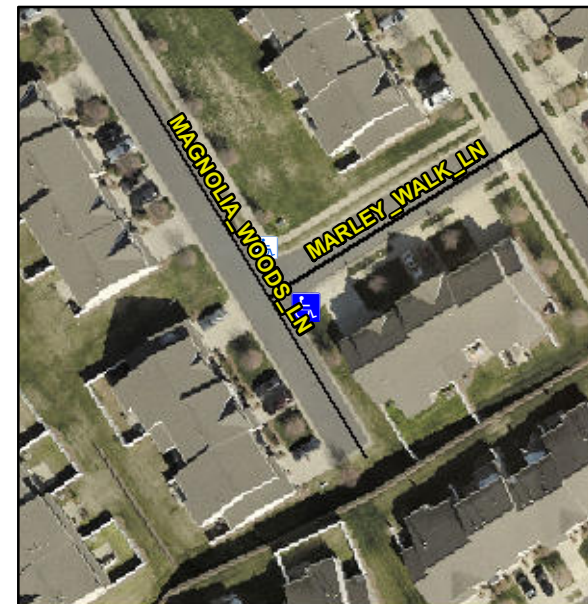
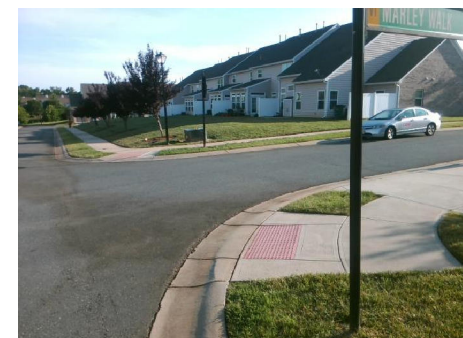
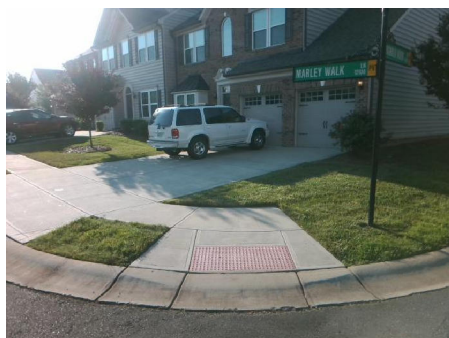
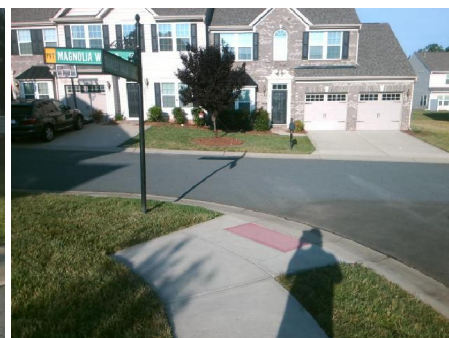
Not Found, R304.2.2, R304.5.3

Compliance	Description	Data	Compliance	Description	Data
N/A	Ramp Length (in)	95.0	No	Ramp Slope (%)	8.6
Yes	Ramp Width (in)	48.0	No	Ramp XSlope (%)	3.0
N/A	Flare Type LT	N/A	N/A	Flare Type RT	N/A
N/A	Flare Slope LT (%)	N/A	N/A	Flare Slope RT (%)	N/A
N/A	Flare Traversable LT?	N/A	N/A	Flare Traversable RT?	N/A
N/A	Landing Length (in)	N/A	N/A	DWS Provided?	N/A
N/A	Landing Width (in)	N/A	N/A	DWS Contrast?	N/A
N/A	Landing Slope (%)	N/A	N/A	DWS Length (in)	N/A
N/A	Landing X Slope (%)	N/A	N/A	DWS Full Width?	N/A
N/A	Landing Curb? (Y/N)	N/A	N/A	DWS Offset (in)	N/A
N/A	Shared Landing?	N/A			
N/A	Gutter Ponding?	N/A	N/A	Gutter Slope (%)	N/A
N/A	Gutter Lip Ht (in)	N/A	N/A	Gutter X Slope (%)	N/A
N/A	Painted X Walk1?	No	N/A	Painted X Walk2?	No
	X Walk 1 Direction	To NW		X Walk 2 Direction	To W
N/A	X Walk 1 Width (in)	N/A	N/A	X Walk 2 Width (in)	N/A
	X Walk 1 Slope (%)	2.4		X Walk 2 Slope (%)	1.0
	X Walk 1 X Slope (%)	0.9		X Walk 2 X Slope (%)	2.2

N/A	Ramp inside XWalk1?	N/A	N/A	Ramp inside XWalk2?	N/A
	Road Slope (%)	0.5	N/A	Clear Space?	N/A
	Road X Slope (%)	1.4	N/A	Clear Space to XWalk (in)	N/A
N/A	Any Obstructions?	N/A	N/A	Storm Grate/Utility Hazard?	N/A
	Obstruction Type			Storm Grate/Utility Type	
		N/A			N/A
		Yes		Surface Condition? (G/P)	Good

Possible Solutions:

Remove & Replace Curb Ramp With Two New Directional Ramps or Equivalent.
