# Access Compliance Report

## Public Rights-of-Way

### (Curb Ramps)

| Intersection ID: 10822 | Main Street: PINCKNEY_AV | Cross Street: E_28TH_ST | Location: W |

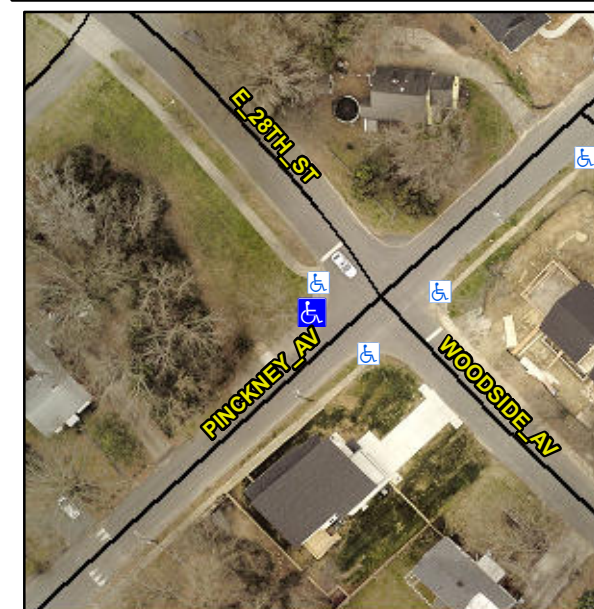
| ADA ID: F63CC15CEE88 | Ramp Type: BlendTrans1 | Initial Pass/Fail: Pass | Overall Compliance: No |
| Severity Score: 9 | | | |

**R304.2.1, R304.5.4**

| Compliance | Description | Data | Compliance | Description | Data |
|---|---|---|---|---|---|
| No | Landing Length (in) | 45.0 | Yes | DWS Provided? | Yes |
| No | Landing Width (in) | 47.0 | Yes | DWS Contrast? | Yes |
| Yes | Gutter Ponding? | No | No | Gutter Slope (%) | 6.1 |

Possible Solutions:

**Remove & Replace Landing.  
Remove & Replace Gutter.**

Total Cost: \$ 1250.00
