Access Compliance Report Public Rights-of-Way (Curb Ramps)

Intersection ID: 12266Main Street:MORRIS_FIELD_DRCross Street:WILKINSON_BVLocation:SWADA ID: F63EA81AAD29Ramp Type:PerpInitial Pass/Fail:FailOverall Compliance:NoSeverity Score:22.5

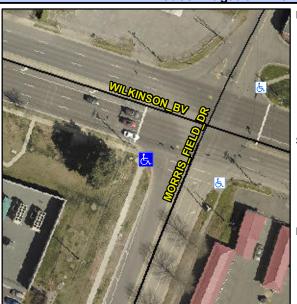
Not Found, R304.5.1, R304.2.2, R304.5.3

Field Measurements/Component Compliance						
Comp	liance Description	Data	Comp	liance Description	Data	
N/A	Ramp Length (in)	60.0	No	Ramp Slope (%)	9.0	
No	Ramp Width (in)	40.0	No	Ramp XSlope (%)	3.2	
N/A	Flare Type LT	N/A	N/A	Flare Type RT	N/A	
N/A	Flare Slope LT (%)	N/A	N/A	Flare Slope RT (%)	N/A	
N/A	Flare Traversable LT?	N/A	N/A	Flare Traversable RT?	N/A	
N/A	Landing Length (in)	N/A	N/A	DWS Provided?	N/A	
N/A	Landing Width (in)	N/A	N/A	DWS Contrast?	N/A	
N/A	Landing Slope (%)	N/A	N/A	DWS Length (in)	N/A	
N/A	Landing X Slope (%)	N/A	N/A	DWS Full Width?	N/A	
N/A	Landing Curb? (Y/N)	N/A	N/A	DWS Offset (in)	N/A	
N/A	Shared Landing?	N/A				
N/A	Gutter Ponding?	N/A	N/A	Gutter Slope (%)	N/A	
N/A	Gutter Lip Ht (in)	N/A	N/A	Gutter X Slope (%)	N/A	
N/A	Painted X Walk1?	Yes	N/A	Painted X Walk2?	N/A	
	X Walk 1 Direction	To SE		X Walk 2 Direction	N/A	
N/A	X Walk 1 Width (in)	110.0	N/A	X Walk 2 Width (in)	N/A	
	X Walk 1 Slope (%)	2.1		X Walk 2 Slope (%)	N/A

X Walk 1 X Slope (%)	0.6		X Walk 2 X Slope (%)	N/A	
N/A	Ramp inside XWalk1?	Yes	N/A	Ramp inside XWalk2?	N/A	
	Road Slope (%)	N/A	N/A	Clear Space?	N/A	
	Road X Slope (%)	N/A	N/A	Clear Space to XWalk (in)	N/A	
N/A	Any Obstructions?	N/A	N/A	Storm Grate/Utility Hazard	? N/A	
	Obstruction Type		l	Storm Grate/Utility Type		
		N/A			N/A	
			Yes	Surface Condition? (G/P)	Good

Remove & Replace Entire Ramp.
