# Access Compliance Report

## Public Rights-of-Way

### (Curb Ramps)

Intersection ID: 10027413	Main Street: GOLF_LINKS_DR_N	Cross Street: N/A	Location: SE
ADA ID: F644449335CE	Ramp Type: Perp	Initial Pass/Fail: Fail	Overall Compliance: No
Severity Score: 1.25			
Codes/Mitigation Info/Possible Solution		Field Measurements/Component Compliance

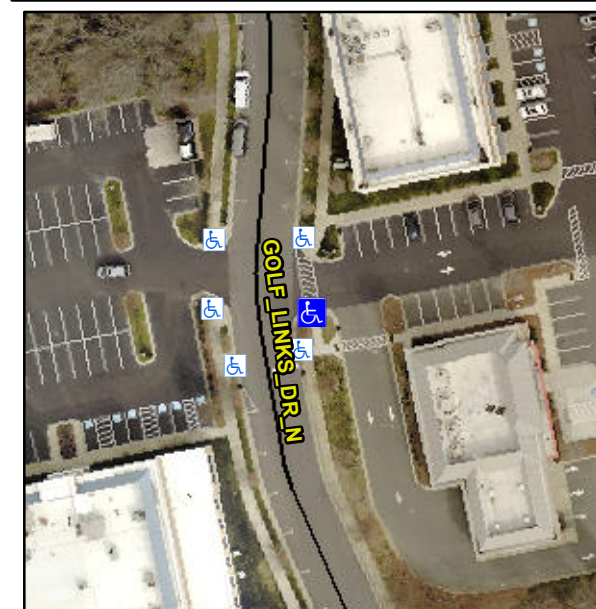
**Not Found, R304.5.3**

Compliance	Description	Data	Compliance	Description	Data
N/A	Ramp Length (in)	60.0	Yes	Ramp Slope (%)	6.0
Yes	Ramp Width (in)	50.0	No	Ramp XSlope (%)	2.2
N/A	Flare Type LT	N/A	N/A	Flare Type RT	N/A
N/A	Flare Slope LT (%)	N/A	N/A	Flare Slope RT (%)	N/A
N/A	Flare Traversable LT?	N/A	N/A	Flare Traversable RT?	N/A
N/A	Landing Length (in)	N/A	N/A	DWS Provided?	N/A
N/A	Landing Width (in)	N/A	N/A	DWS Contrast?	N/A
N/A	Landing Slope (%)	N/A	N/A	DWS Length (in)	N/A
N/A	Landing X Slope (%)	N/A	N/A	DWS Full Width?	N/A
N/A	Landing Curb? (Y/N)	N/A	N/A	DWS Offset (in)	N/A
N/A	Shared Landing?	N/A			
N/A	Gutter Ponding?	N/A	N/A	Gutter Slope (%)	N/A
N/A	Gutter Lip Ht (in)	N/A	N/A	Gutter X Slope (%)	N/A
N/A	Painted X Walk1?	Yes	N/A	Painted X Walk2?	N/A
	X Walk 1 Direction	To N		X Walk 2 Direction	N/A
N/A	X Walk 1 Width (in)	88.0	N/A	X Walk 2 Width (in)	N/A
	X Walk 1 Slope (%)	0.7		X Walk 2 Slope (%)	N/A
	X Walk 1 X Slope (%)	2.6		X Walk 2 X Slope (%)	N/A

N/A	Ramp inside XWalk1?	Yes	N/A	Ramp inside XWalk2?	N/A
	Road Slope (%)	N/A	N/A	Clear Space?	N/A
	Road X Slope (%)	N/A	N/A	Clear Space to XWalk (in)	N/A
N/A	Any Obstructions?	N/A	N/A	Storm Grate/Utility Hazard?	N/A
	Obstruction Type			Storm Grate/Utility Type	
		N/A			N/A
		Yes		Surface Condition? (G/P)	Good

**Remove & Replace Entire Ramp.**
