Access Compliance Report Public Rights-of-Way (Curb Ramps)

Intersection ID: 13434 Main Street: E_MOREHEAD_ST Cross Street: S_CALDWELL_ST Location: NE

ADA ID: F6482A8A4CCF Ramp Type: PerpDiag Initial Pass/Fail: Fail Overall Compliance: No Severity Score: 25

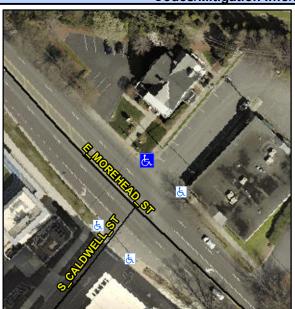
R304.2.2, R304.5.3

Compliance Description		Data	Comp	oliance	Description	Data
N/A	Ramp Length (in)	60.0	No	Ramp	Slope (%)	11.0
Yes	Ramp Width (in)	48.0	No	Ramp	XSlope (%)	6.7
N/A	Flare Type LT	N/A	N/A	Flare	Type RT	N/A
N/A	Flare Slope LT (%)	N/A	N/A	Flare	Slope RT (%)	N/A
N/A	Flare Traversable LT?	N/A	N/A	Flare	Traversable RT?	N/A
N/A	Landing Length (in)	N/A	N/A	DWS	Provided?	N/A
N/A	Landing Width (in)	N/A	N/A	DWS	Contrast?	N/A
N/A	Landing Slope (%)	N/A	N/A	DWS	Length (in)	N/A
N/A	Landing X Slope (%)	N/A	N/A	DWS	Full Width?	N/A
N/A	Landing Curb? (Y/N)	N/A	N/A	DWS	Offset (in)	N/A
N/A	Shared Landing?	N/A				
N/A	Gutter Ponding?	N/A	N/A	Gutte	r Slope (%)	N/A
N/A	Gutter Lip Ht (in)	3.0	N/A	Gutte	r X Slope (%)	N/A
N/A	Painted X Walk1?	No	N/A	Paint	ed X Walk2?	No
	X Walk 1 Direction	To SW		X Wa	lk 2 Direction	To SE
N/A	X Walk 1 Width (in)	N/A	N/A	X Wa	lk 2 Width (in)	N/A
	X Walk 1 Slope (%)	6.0		X Wa	lk 2 Slope (%)	0.2
	X Walk 1 X Slope (%)	1.6		X Wa	lk 2 X Slope (%)	5.4

N/A	Ramp inside XWalk1?	N/A	N/A	Ram	inside XWalk2?	N/A
	Road Slope (%)	5.4	N/A	Clear	Space?	N/A
	Road X Slope (%)	1.1	N/A	Clear	Space to XWalk (in)	N/A
N/A	Any Obstructions?	N/A	N/A	Storn	n Grate/Utility Hazard?	N/A
	Obstruction Type			Storn	n Grate/Utility Type	
		N/A				N/A
			١.,		/

Remove & Replace Curb Ramp With
Two New Directional Ramps or
Equivalent.
