Access Compliance Report Public Rights-of-Way (Curb Ramps)

Intersection ID: 10054 Main Street: ROZZELLES_FERRY_RD Cross Street: S_SMALLWOOD_PL Location: NW

ADA ID: F64A7C21DC91 Ramp Type: PerpDiag Initial Pass/Fail: Fail Overall Compliance: No Severity Score: 22.5

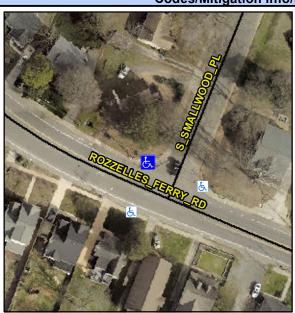
Not Found, R304.5.1, R304.2.2, R304.5.3

Field Measurements/Component Compliance					
Compliance Description		Data	Compliance Description		Data
N/A	Ramp Length (in)	56.0	No	Ramp Slope (%)	9.2
No	Ramp Width (in)	42.0	No	Ramp XSlope (%)	3.5
N/A	Flare Type LT	N/A	N/A	Flare Type RT	N/A
N/A	Flare Slope LT (%)	N/A	N/A	Flare Slope RT (%)	N/A
N/A	Flare Traversable LT?	N/A	N/A	Flare Traversable R	Γ? N/A
N/A	Landing Length (in)	N/A	N/A	DWS Provided?	N/A
N/A	Landing Width (in)	N/A	N/A	DWS Contrast?	N/A
N/A	Landing Slope (%)	N/A	N/A	DWS Length (in)	N/A
N/A	Landing X Slope (%)	N/A	N/A	DWS Full Width?	N/A
N/A	Landing Curb? (Y/N)	N/A	N/A	DWS Offset (in)	N/A
N/A	Shared Landing?	N/A			
N/A	Gutter Ponding?	N/A	N/A	Gutter Slope (%)	N/A
N/A	Gutter Lip Ht (in)	N/A	N/A	Gutter X Slope (%)	N/A
N/A	Painted X Walk1?	No	N/A	Painted X Walk2?	No
	X Walk 1 Direction	To SW		X Walk 2 Direction	To SE
N/A	X Walk 1 Width (in)	N/A	N/A	X Walk 2 Width (in)	N/A
	X Walk 1 Slope (%)	3.9		X Walk 2 Slope (%)	6.6

X Walk 1 X Slope (%)	4.2		X Walk 2 X Slope (%	0.0
N/A	Ramp inside XWalk1?	N/A	N/A	Ramp inside XWalk2	2? N/A
	Road Slope (%)	4.2	N/A	Clear Space?	N/A
	Road X Slope (%)	4.1	N/A	Clear Space to XWa	lk (in) N/A
N/A	Any Obstructions?	N/A	N/A	Storm Grate/Utility F	lazard? N/A
	Obstruction Type			Storm Grate/Utility T	уре
		N/A			N/A
			Yes	Surface Condition?	(G/P) Good

ROZZELLES FERRY RD None S SMALLWOOD PL StopSign Possible Solutions:

Remove & Replace Curb Ramp With Two New Directional Ramps or Equivalent.
