Access Compliance Report

Public Rights-of-Way

(Curb Ramps)

Intersection ID: 29688	Main Street: BIG_PINE_DR	Cross Street: EQUESTRIAN_DR	Location:	N
ADA ID: F6526CDCB5F6	Ramp Type: Perp	Initial Pass/Fail: Pass	Overall Compliance: No	Severity Score: 15
Codes/Mitigation Info/Possible Solution		Field Measurements/Component Compliance

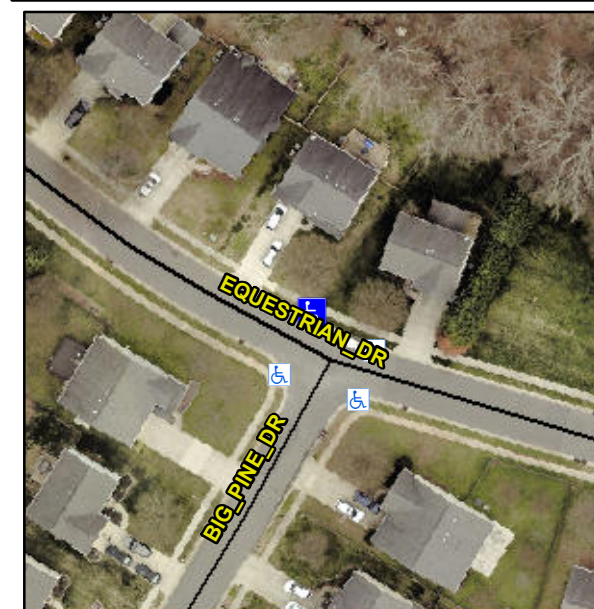
Not Found, R305, R304.5.4, R304.5.3

Compliance	Description	Data	Compliance	Description	Data
N/A	Ramp Length (in)	53.0	Yes	Ramp Slope (%)	7.9
Yes	Ramp Width (in)	55.0	Yes	Ramp XSlope (%)	1.2
N/A	Flare Type LT	Sloped	N/A	Flare Type RT	N/A
N/A	Flare Slope LT (%)	2.7	Yes	Flare Slope RT (%)	5.6
N/A	Flare Traversable LT?	Yes	N/A	Flare Traversable RT?	Yes
Yes	Landing Length (in)	48.0	No	DWS Provided?	No
Yes	Landing Width (in)	55.0	N/A	DWS Contrast?	No
Yes	Landing Slope (%)	1.9	N/A	DWS Length (in)	N/A
Yes	Landing X Slope (%)	0.7	N/A	DWS Full Width?	No
N/A	Landing Curb? (Y/N)	No	N/A	DWS Offset (in)	N/A
N/A	Shared Landing?	No			
Yes	Gutter Ponding?	No	No	Gutter Slope (%)	11.8
Yes	Gutter Lip Ht (in)	0.0	No	Gutter X Slope (%)	2.3
N/A	Painted X Walk1?	No	N/A	Painted X Walk2?	N/A
	X Walk 1 Direction	To SW		X Walk 2 Direction	N/A
N/A	X Walk 1 Width (in)	N/A	N/A	X Walk 2 Width (in)	N/A
	X Walk 1 Slope (%)	4.7		X Walk 2 Slope (%)	N/A
	X Walk 1 X Slope (%)	0.9		X Walk 2 X Slope (%)	N/A

N/A	Ramp inside XWalk1?	N/A	N/A	Ramp inside XWalk2?	N/A
	Road Slope (%)	N/A	N/A	Clear Space?	Yes
	Road X Slope (%)	N/A	N/A	Clear Space to XWalk (in)	N/A
Yes	Any Obstructions?	No	Yes	Storm Grate/Utility Hazard?	No
	Obstruction Type			Storm Grate/Utility Type	
		N/A			N/A
			Yes	Surface Condition? (G/P)	Good

**Remove & Replace Entire Ramp.
Remove & Replace Gutter.**
