Access Compliance Report

Public Rights-of-Way

(Curb Ramps)

Intersection ID: N/A	Main Street: SARDIS_RD_NORTH	Cross Street: N/A	Location: S
ADA ID: F6543967E725	Ramp Type: Para	Initial Pass/Fail: Fail	Overall Compliance: No
Codes/Mitigation Info/Possible Solution		Field Measurements/Component Compliance	
Severity Score: 12.5

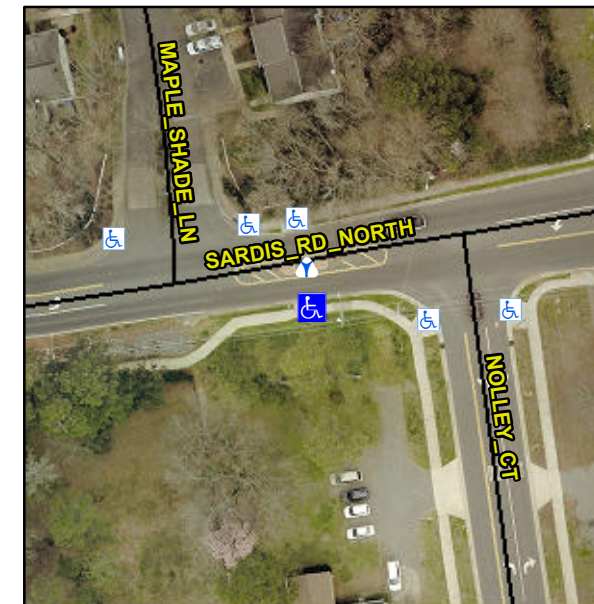
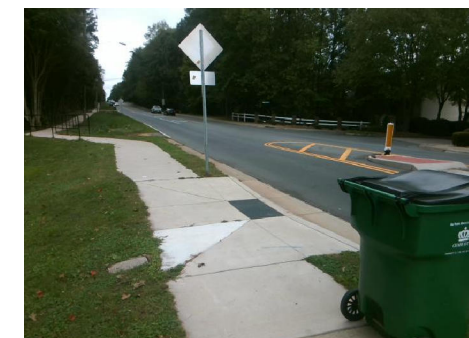
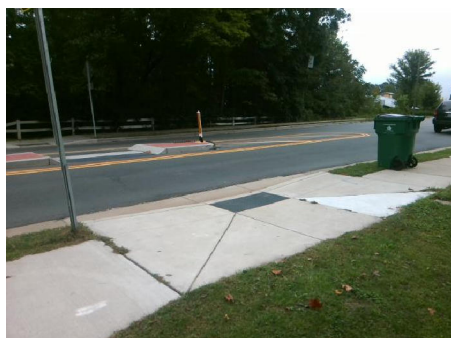
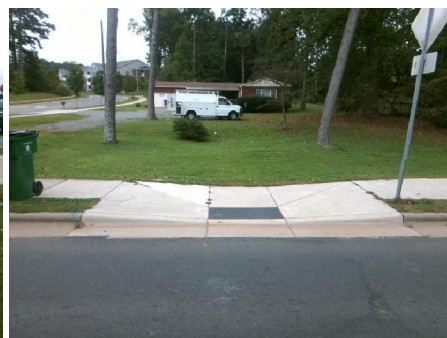
Compliance	Description	Data	Compliance	Description	Data
N/A	Ramp Length LT (in)	72.0	N/A	Ramp Length RT (in)	72.0
Yes	Ramp Width LT (in)	60.0	Yes	Ramp Width RT (in)	60.0
No	Ramp Slope LT (%)	8.4	Yes	Ramp Slope RT (%)	8.0
Yes	Ramp XSlope LT (%)	1.9	Yes	Ramp XSlope RT (%)	1.4
N/A	Landing Length (in)	N/A	N/A	DWS Provided?	N/A
N/A	Landing Width (in)	N/A	N/A	DWS Contrast?	N/A
N/A	Landing Slope (%)	N/A	N/A	DWS Length (in)	N/A
N/A	Landing X Slope (%)	N/A	N/A	DWS Full Width?	N/A
N/A	Landing Curb? (Y/N)	N/A	N/A	DWS Offset (in)	N/A
N/A	Shared Landing?	N/A			
N/A	Gutter Ponding?	N/A	N/A	Gutter Slope (%)	N/A
N/A	Gutter Lip Ht (in)	N/A	N/A	Gutter X Slope (%)	N/A
N/A	Painted X Walk1?	No	N/A	Painted X Walk2?	N/A
	X Walk 1 Direction	To NW		X Walk 2 Direction	N/A
N/A	X Walk 1 Width (in)	N/A	N/A	X Walk 2 Width (in)	N/A
	X Walk 1 Slope (%)	3.8		X Walk 2 Slope (%)	N/A
	X Walk 1 X Slope (%)	1.5		X Walk 2 X Slope (%)	N/A
N/A	Ramp inside XWalk1?	N/A	N/A	Ramp inside XWalk2?	N/A

Road Slope (%)	N/A	N/A	Clear Space?	N/A
	Road X Slope (%)	N/A	N/A	Clear Space to XWalk (in)	N/A
N/A	Any Obstructions?	N/A	N/A	Storm Grate/Utility Hazard?	N/A
	Obstruction Type			Storm Grate/Utility Type	
		N/A			N/A
			Yes	Surface Condition? (G/P)	Good
			N/A	Curb Slope (%)	9.3

Remove & Replace Entire Ramp.

R304.3.2

\$ 1600.00
