# Access Compliance Report

## Public Rights-of-Way

### (Curb Ramps)

Intersection ID: 20203	Main Street: LANSING_DR	Cross Street: WINGRAVE_DR	Location: NW
ADA ID: F6543B522F20	Ramp Type: BlendTrans1	Initial Pass/Fail: Fail	Overall Compliance: No
		Severity Score: 25

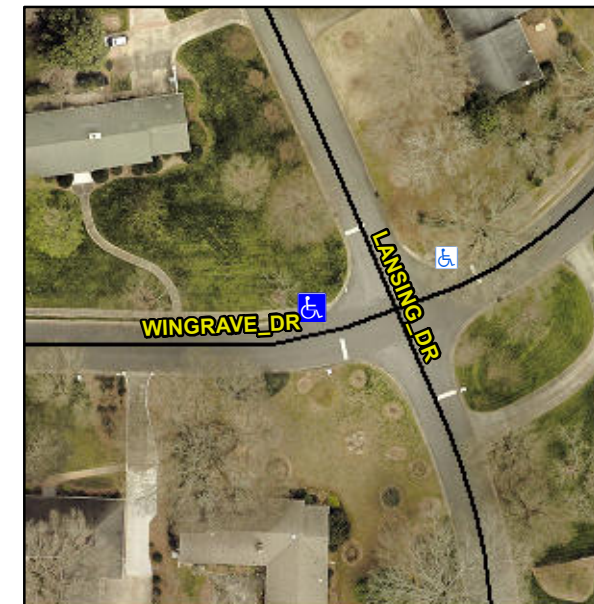
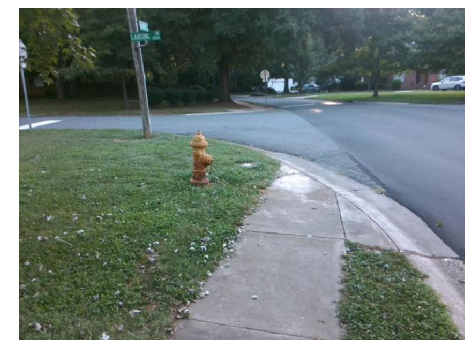
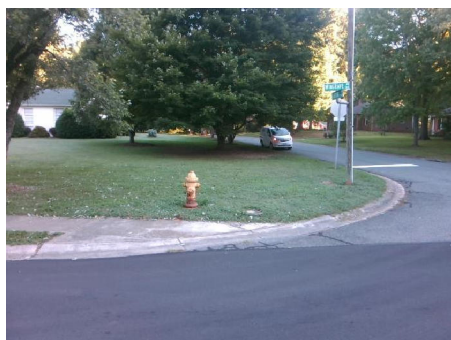
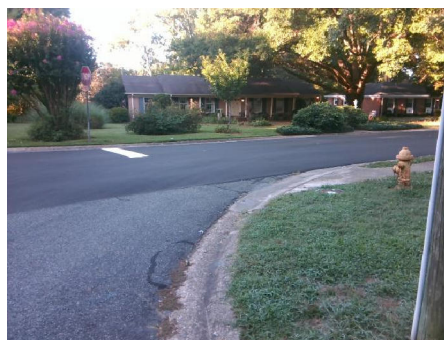
**Not Found, R304.5.3**

Compliance	Description	Data	Compliance	Description	Data
N/A	Ramp Length (in)	76.0	Yes	BlendTrans Slope (%)	2.3
Yes	Ramp Width (in)	48.0	No	BlendTrans XSlope (%)	7.8
N/A	Flare Type LT	N/A	N/A	Flare Type RT	N/A
N/A	Flare Slope LT (%)	N/A	N/A	Flare Slope RT (%)	N/A
N/A	Flare Traversable LT?	N/A	N/A	Flare Traversable RT?	N/A
N/A	Landing Length (in)	N/A	N/A	DWS Provided?	N/A
N/A	Landing Width (in)	N/A	N/A	DWS Contrast?	N/A
N/A	Landing Slope (%)	N/A	N/A	DWS Length (in)	N/A
N/A	Landing X Slope (%)	N/A	N/A	DWS Full Width?	N/A
N/A	Landing Curb? (Y/N)	N/A	N/A	DWS Offset (in)	N/A
N/A	Shared Landing?	N/A			
N/A	Gutter Ponding?	N/A	N/A	Gutter Slope (%)	N/A
N/A	Gutter Lip Ht (in)	N/A	N/A	Gutter X Slope (%)	N/A
N/A	Painted X Walk1?	No	N/A	Painted X Walk2?	No
	X Walk 1 Direction	To S		X Walk 2 Direction	To NE
	X Walk 1 Width (in)	N/A		X Walk 2 Width (in)	N/A
	X Walk 1 Slope (%)	3.8		X Walk 2 Slope (%)	4.2
	X Walk 1 X Slope (%)	3.2		X Walk 2 X Slope (%)	1.6

N/A	Ramp inside XWalk1?	N/A	N/A	Ramp inside XWalk2?	N/A
	Road Slope (%)	1.3		Clear Space?	N/A
	Road X Slope (%)	4.4	N/A	Clear Space to XWalk (in)	N/A
N/A	Any Obstructions?	N/A	N/A	Storm Grate/Utility Hazard?	N/A
	Obstruction Type			Storm Grate/Utility Type	
		N/A			N/A
			Yes	Surface Condition? (G/P)	Good
			No	Curb Slope (%)	9.9

**Remove & Replace Curb Ramp With Two New Directional Ramps or Equivalent.**
