# Access Compliance Report

## Public Rights-of-Way

### (Curb Ramps)

Intersection ID: 13802	Main Street: LEXINGTON_AV	Cross Street: MYRTLE_AV	Location: S
ADA ID: F6673F7A93EE	Ramp Type: Perp	Initial Pass/Fail: Fail	Overall Compliance: No
		Severity Score: 1.25	
Codes/Mitigation Info/Possible Solution		Field Measurements/Component Compliance

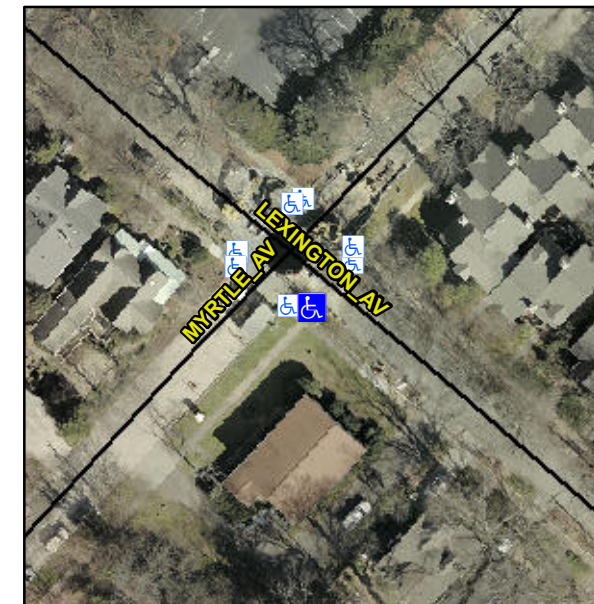
**Not Found, R304.5.3**

Compliance	Description	Data	Compliance	Description	Data
N/A	Ramp Length (in)	87.0	Yes	Ramp Slope (%)	6.9
Yes	Ramp Width (in)	50.0	No	Ramp XSlope (%)	3.7
N/A	Flare Type LT	N/A	N/A	Flare Type RT	N/A
N/A	Flare Slope LT (%)	N/A	N/A	Flare Slope RT (%)	N/A
N/A	Flare Traversable LT?	N/A	N/A	Flare Traversable RT?	N/A
N/A	Landing Length (in)	N/A	N/A	DWS Provided?	N/A
N/A	Landing Width (in)	N/A	N/A	DWS Contrast?	N/A
N/A	Landing Slope (%)	N/A	N/A	DWS Length (in)	N/A
N/A	Landing X Slope (%)	N/A	N/A	DWS Full Width?	N/A
N/A	Landing Curb? (Y/N)	N/A	N/A	DWS Offset (in)	N/A
N/A	Shared Landing?	N/A			
N/A	Gutter Ponding?	N/A	N/A	Gutter Slope (%)	N/A
N/A	Gutter Lip Ht (in)	N/A	N/A	Gutter X Slope (%)	N/A
N/A	Painted X Walk1?	No	N/A	Painted X Walk2?	N/A
	X Walk 1 Direction	To NE		X Walk 2 Direction	N/A
N/A	X Walk 1 Width (in)	N/A	N/A	X Walk 2 Width (in)	N/A
	X Walk 1 Slope (%)	4.3		X Walk 2 Slope (%)	N/A
	X Walk 1 X Slope (%)	4.7		X Walk 2 X Slope (%)	N/A

N/A	Ramp inside XWalk1?	N/A	N/A	Ramp inside XWalk2?	N/A
	Road Slope (%)	N/A	N/A	Clear Space?	N/A
	Road X Slope (%)	N/A	N/A	Clear Space to XWalk (in)	N/A
N/A	Any Obstructions?	N/A	N/A	Storm Grate/Utility Hazard?	N/A
	Obstruction Type			Storm Grate/Utility Type	
		N/A			N/A
		Yes		Surface Condition? (G/P)	Good

**Remove & Replace Entire Ramp.**

Total Cost: \$ 1850.00
