Access Compliance Report

Public Rights-of-Way

(Curb Ramps)

| Intersection ID: 10021328 | Main Street: BLAKENEY_HEATH_RD | Cross Street: N/A | Location: NE |

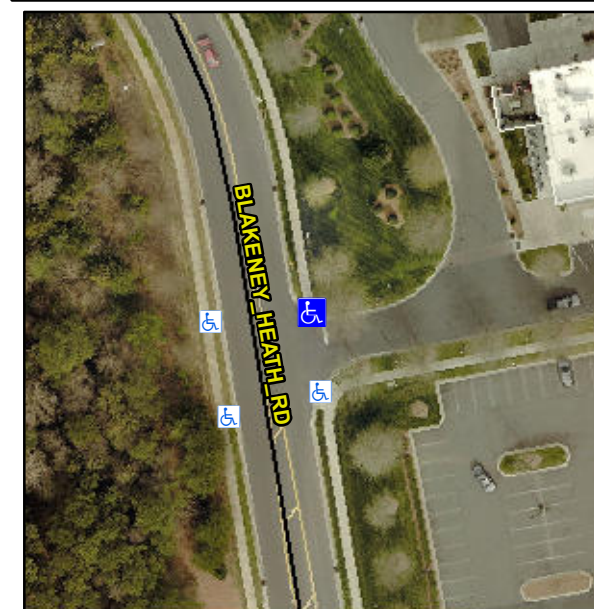
| ADA ID: F667DBFA27E3 | Ramp Type: PerpDiag | Initial Pass/Fail: Fail | Overall Compliance: No |
| Severity Score: 33.75 | | | |

R304.5.1, R304.2.2, R304.5.3

| Compliance | Description | Data | Compliance | Description | Data |
|---|---|---|---|---|---|
| N/A | Ramp Length (in) | 44.0 | No | Ramp Slope (%) | 9.2 |
| No | Ramp Width (in) | 46.5 | No | Ramp XSlope (%) | 5.8 |

Remove & Replace Curb Ramp With Two New Directional Ramps or Equivalent.

Total Cost: \$ 3200.00
