Access Compliance Report

Public Rights-of-Way

(Curb Ramps)

Intersection ID: 11748	Main Street: BERRYHILL_RD	Cross Street: FLEETWOOD_DR	Location: S
ADA ID: F66BC58C420E	Ramp Type: Perp	Initial Pass/Fail: Fail	Overall Compliance: No
Severity Score: 8.75			
Codes/Mitigation Info/Possible Solution		Field Measurements/Component Compliance

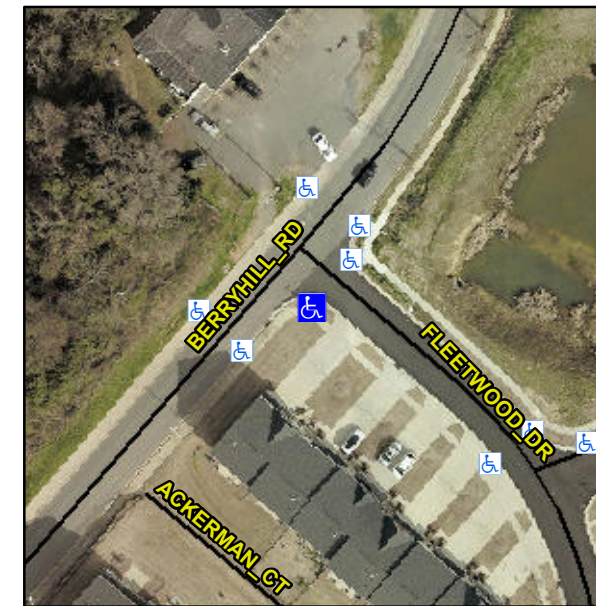
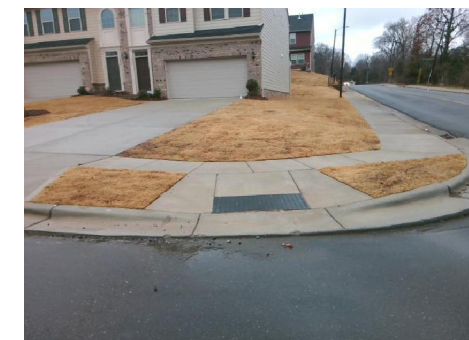
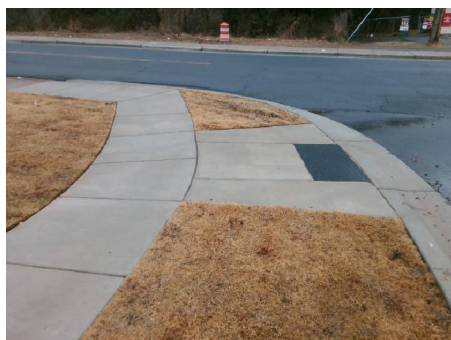
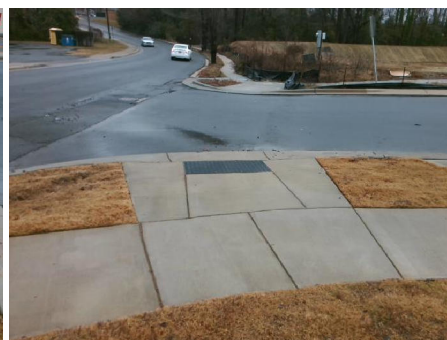
Not Found, R304.5.1

Compliance	Description	Data	Compliance	Description	Data
N/A	Ramp Length (in)	73.5	Yes	Ramp Slope (%)	6.3
No	Ramp Width (in)	47.0	Yes	Ramp XSlope (%)	1.3
N/A	Flare Type LT	N/A	N/A	Flare Type RT	N/A
N/A	Flare Slope LT (%)	N/A	N/A	Flare Slope RT (%)	N/A
N/A	Flare Traversable LT?	N/A	N/A	Flare Traversable RT?	N/A
N/A	Landing Length (in)	N/A	N/A	DWS Provided?	N/A
N/A	Landing Width (in)	N/A	N/A	DWS Contrast?	N/A
N/A	Landing Slope (%)	N/A	N/A	DWS Length (in)	N/A
N/A	Landing X Slope (%)	N/A	N/A	DWS Full Width?	N/A
N/A	Landing Curb? (Y/N)	N/A	N/A	DWS Offset (in)	N/A
N/A	Shared Landing?	N/A			
N/A	Gutter Ponding?	N/A	N/A	Gutter Slope (%)	N/A
N/A	Gutter Lip Ht (in)	N/A	N/A	Gutter X Slope (%)	N/A
N/A	Painted X Walk1?	No	N/A	Painted X Walk2?	N/A
	X Walk 1 Direction	To NE		X Walk 2 Direction	N/A
N/A	X Walk 1 Width (in)	N/A	N/A	X Walk 2 Width (in)	N/A
	X Walk 1 Slope (%)	1.5		X Walk 2 Slope (%)	N/A
	X Walk 1 X Slope (%)	5.8		X Walk 2 X Slope (%)	N/A

N/A	Ramp inside XWalk1?	N/A	N/A	Ramp inside XWalk2?	N/A
	Road Slope (%)	N/A	N/A	Clear Space?	N/A
	Road X Slope (%)	N/A	N/A	Clear Space to XWalk (in)	N/A
N/A	Any Obstructions?	N/A	N/A	Storm Grate/Utility Hazard?	N/A
	Obstruction Type			Storm Grate/Utility Type	
		N/A			N/A
			Yes	Surface Condition? (G/P)	Good

Remove & Replace Entire Ramp.
