# Access Compliance Report

## Public Rights-of-Way (Curb Ramps)

Intersection ID: 54301	Main Street: GOLF_LINKS_DR	Cross Street: PROVIDENCE_FARM_LN	Location: SW
ADA ID: F66D8BA7346A	Ramp Type: Directional1	Initial Pass/Fail: Fail	Overall Compliance: No
Severity Score: 12.5			
Codes/Mitigation Info/Possible Solution		Field Measurements/Component Compliance

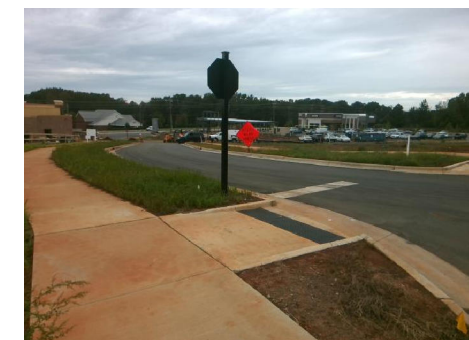
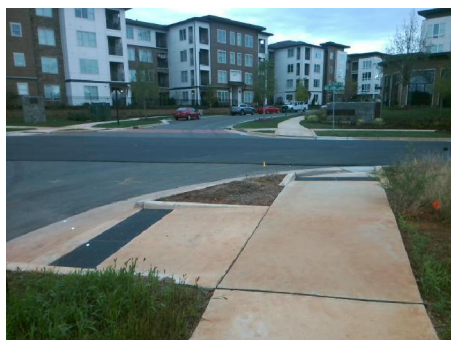
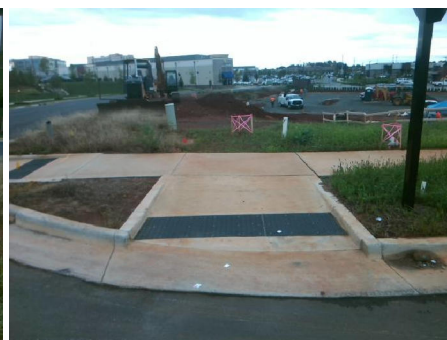
Compliance	Description	Data	Compliance	Description	Data
N/A	Ramp Length (in)	91.0	N/A	Grade Break?	N/A
Yes	Ramp Width (in)	94.0	N/A	Grade Break Slope (%)	0.0
Yes	Ramp Slope (%)	7.1	N/A	Grade Break XSlope (%)	0.0
No	Ramp XSlope (%)	5.7			
N/A	Flare Type LT	N/A	N/A	Flare Type RT	N/A
N/A	Flare Slope LT (%)	N/A	N/A	Flare Slope RT (%)	0.0
N/A	Flare Traversable LT?	N/A	N/A	Flare Traversable RT?	N/A
N/A	Landing Length (in)	0.0	N/A	DWS Provided?	N/A
N/A	Landing Width (in)	0.0	N/A	DWS Contrast?	N/A
N/A	Landing Slope (%)	0.0	N/A	DWS Length (in)	N/A
N/A	Landing X Slope (%)	0.0	N/A	DWS Full Width?	N/A
N/A	Landing Curb? (Y/N)	N/A	N/A	DWS Offset LT (in)	N/A
N/A	Shared Landing?	N/A	N/A	DWS Offset RT (in)	N/A
N/A	Gutter Ponding?	0.0	N/A	Gutter Slope (%)	N/A
N/A	Gutter Lip Ht (in)	0.0	N/A	Gutter X Slope (%)	N/A
N/A	Painted X Walk1?	No		Road Slope (%)	1.1
	X Walk 1 Direction	To NW		Road X Slope (%)	1.0
	X Walk 1 Width (in)	N/A		Clear Space?	N/A

X Walk 1 Slope (%)	1.1	N/A	Clear Space to XWalk (in)	N/A
	X Walk 1 X Slope (%)	1.0	N/A	Storm Grate/Utility Hazard?	N/A
N/A	Ramp inside XWalk1?	N/A		Storm Grate/Utility Type	
N/A	Any Obstructions?	N/A			N/A
	Obstruction Type		Yes	Surface Condition? (G/P)	Good
			N/A	Curb Slope (%)	8.6

**Remove & Replace Entire Ramp.**

**R304.5.3**
