Access Compliance Report

Public Rights-of-Way

(Curb Ramps)

Intersection ID: 8070	Main Street: LITTLE ROCK RD	Cross Street: PAW CREEK RD	Location: NE
ADA ID: F67BCA6D56B8	Ramp Type: PerpDiag	Initial Pass/Fail: Pass	Overall Compliance: No
Severity Score: 10.25			
Codes/Mitigation Info/Possible Solution		Field Measurements/Component Compliance

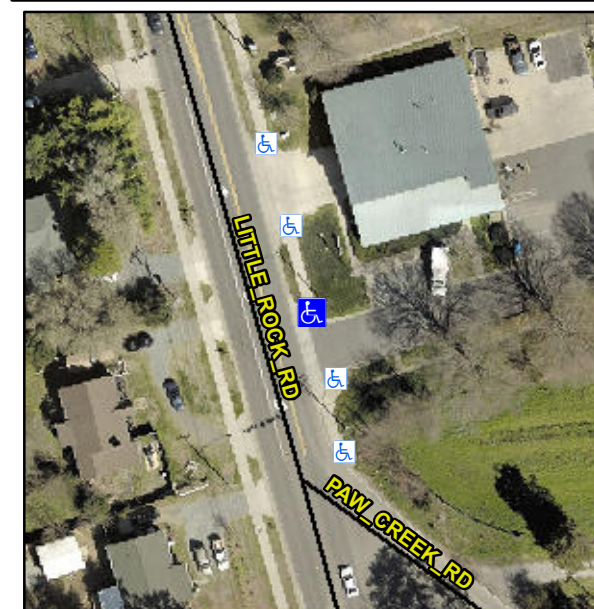
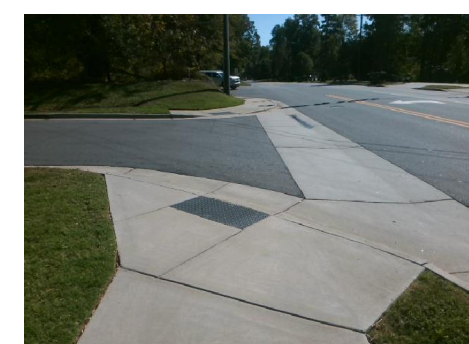
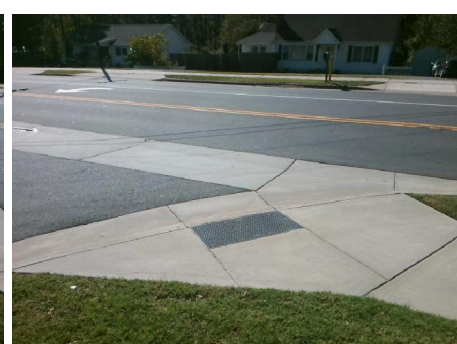
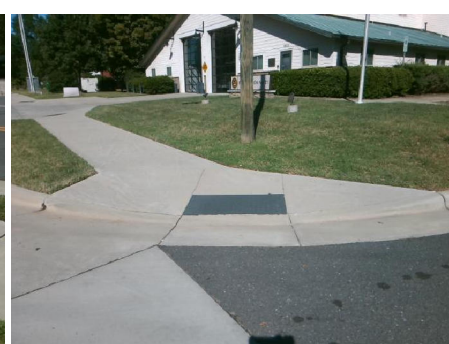
Compliance	Description	Data	Compliance	Description	Data
N/A	Ramp Length (in)	73.0	Yes	Ramp Slope (%)	5.4
Yes	Ramp Width (in)	48.0	No	Ramp XSlope (%)	2.8
N/A	Flare Type LT	Sloped	N/A	Flare Type RT	N/A
N/A	Flare Slope LT (%)	4.3	N/A	Flare Slope RT (%)	6.0
N/A	Flare Traversable LT?	No	N/A	Flare Traversable RT?	No
No	Landing Length (in)	N/A	Yes	DWS Provided?	Yes
No	Landing Width (in)	N/A	Yes	DWS Contrast?	Yes
No	Landing Slope (%)	N/A	Yes	DWS Length (in)	24.0
No	Landing X Slope (%)	N/A	Yes	DWS Full Width?	Yes
N/A	Landing Curb? (Y/N)	No	Yes	DWS Offset (in)	1.5
N/A	Shared Landing?	No			
Yes	Gutter Ponding?	No	Yes	Gutter Slope (%)	1.1
Yes	Gutter Lip Ht (in)	0.0	Yes	Gutter X Slope (%)	0.9
N/A	Painted X Walk1?	No	N/A	Painted X Walk2?	No
	X Walk 1 Direction	To W		X Walk 2 Direction	To S
N/A	X Walk 1 Width (in)	N/A	N/A	X Walk 2 Width (in)	N/A
	X Walk 1 Slope (%)	5.7		X Walk 2 Slope (%)	0.1
	X Walk 1 X Slope (%)	0.1		X Walk 2 X Slope (%)	3.1

N/A	Ramp inside XWalk1?	N/A	N/A	Ramp inside XWalk2?	N/A
	Road Slope (%)	1.4	N/A	Clear Space?	Yes
	Road X Slope (%)	3.0	N/A	Clear Space to XWalk (in)	29.5
Yes	Any Obstructions?	No	Yes	Storm Grate/Utility Hazard?	No
	Obstruction Type			Storm Grate/Utility Type	
		N/A			N/A
		Yes	Yes	Surface Condition? (G/P)	Good

Possible Solutions:

Remove & Replace Curb Ramp With Two New Directional Ramps or Equivalent.
