Access Compliance Report

Public Rights-of-Way

(Curb Ramps)

Intersection ID: 48987	Main Street: ASHTON_GATE_DR	Cross Street: SMITHFIELD_DR	Location:	NE
ADA ID: F67D86D5D619	Ramp Type: BlendTrans2	Initial Pass/Fail: Pass	Overall Compliance: No	Severity Score: 2.5
Codes/Mitigation Info/Possible Solution		Field Measurements/Component Compliance

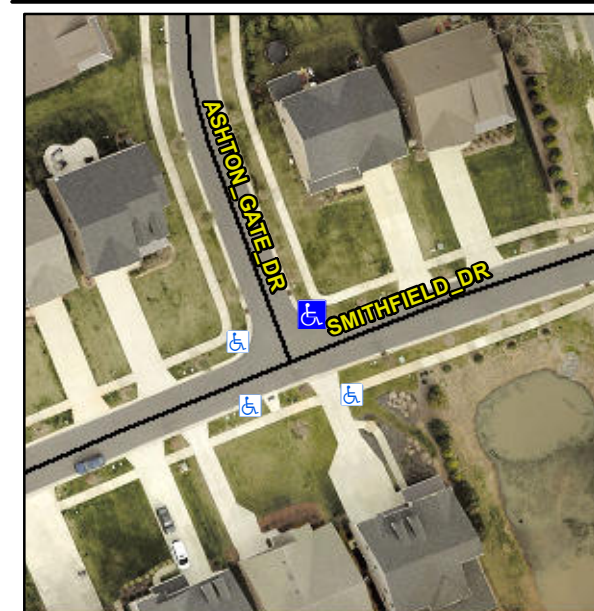
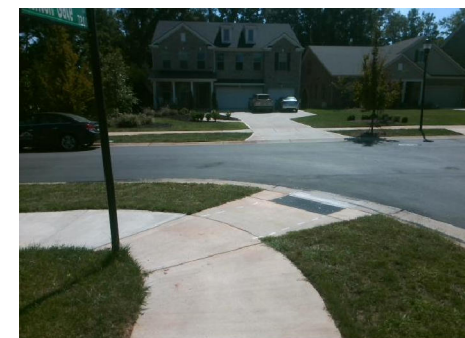
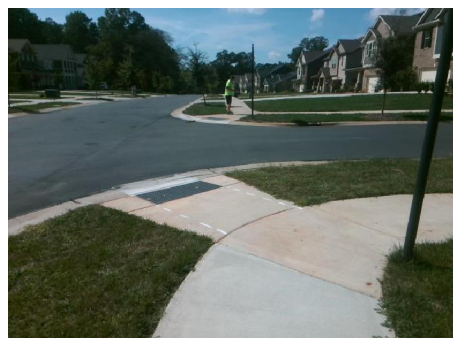
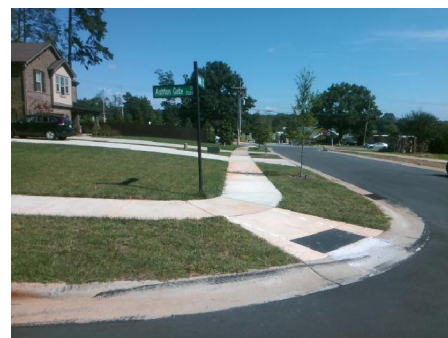
Compliance	Description	Data	Compliance	Description	Data
N/A	Ramp Length (in)	84.0	Yes	BlendTrans Slope (%)	3.5
Yes	Ramp Width (in)	48.0	Yes	BlendTrans XSlope (%)	1.2
N/A	Flare Type LT	Sloped	N/A	Flare Type RT	Sloped
N/A	Flare Slope LT (%)	N/A	N/A	Flare Slope RT (%)	N/A
N/A	Flare Traversable LT?	No	N/A	Flare Traversable RT?	No
N/A	Landing Length (in)	N/A	Yes	DWS Provided?	Yes
N/A	Landing Width (in)	N/A	Yes	DWS Contrast?	Yes
N/A	Landing Slope (%)	N/A	Yes	DWS Length (in)	24.0
N/A	Landing X Slope (%)	N/A	No	DWS Full Width?	No
N/A	Landing Curb? (Y/N)	No	Yes	DWS Offset (in)	2.0
N/A	Shared Landing?	No			
Yes	Gutter Ponding?	No	Yes	Gutter Slope (%)	1.0
Yes	Gutter Lip Ht (in)	0.0	Yes	Gutter X Slope (%)	0.3
N/A	Painted X Walk1?	No	N/A	Painted X Walk2?	No
	X Walk 1 Direction	To W		X Walk 2 Direction	To S
	X Walk 1 Width (in)	N/A		X Walk 2 Width (in)	N/A
	X Walk 1 Slope (%)	0.1		X Walk 2 Slope (%)	2.9
	X Walk 1 X Slope (%)	0.8		X Walk 2 X Slope (%)	0.3

N/A	Ramp inside XWalk1?	N/A	N/A	Ramp inside XWalk2?	N/A
	Road Slope (%)	0.4		Clear Space?	Yes
	Road X Slope (%)	1.4	N/A	Clear Space to XWalk (in)	N/A
Yes	Any Obstructions?	No	Yes	Storm Grate/Utility Hazard?	No
	Obstruction Type			Storm Grate/Utility Type	
		N/A			N/A
			Yes	Surface Condition? (G/P)	Good
			Yes	Curb Slope (%)	2.5

Possible Solutions:

Remove & Replace Detectable Warning System.

R305.1.4
