Access Compliance Report

Public Rights-of-Way

(Curb Ramps)

Intersection ID: 19406	Main Street: SOUTH_BV	Cross Street: BOURBON_ST	Location: SE
ADA ID: F683755E50DA	Ramp Type: Directional1	Initial Pass/Fail: Fail	Overall Compliance: No
Severity Score: 25			
Codes/Mitigation Info/Possible Solution		Field Measurements/Component Compliance

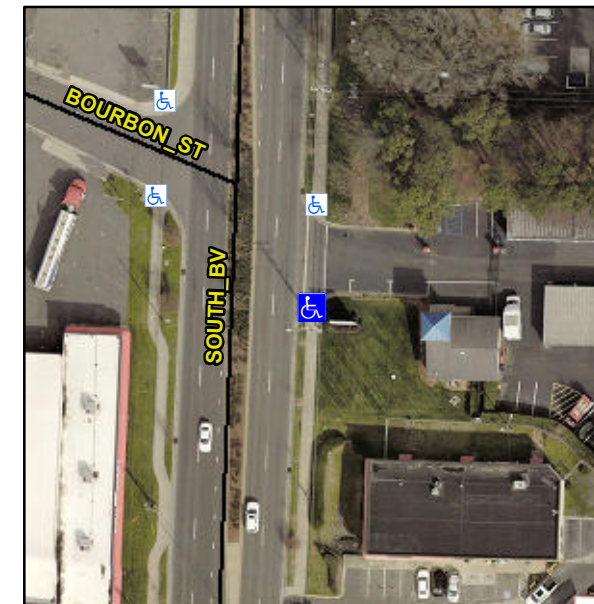
Compliance	Description	Data	Compliance	Description	Data
N/A	Ramp Length (in)	124.0	N/A	Grade Break?	N/A
Yes	Ramp Width (in)	70.0	N/A	Grade Break Slope (%)	0.0
Yes	Ramp Slope (%)	2.9	N/A	Grade Break XSlope (%)	0.0
No	Ramp XSlope (%)	7.6			
N/A	Flare Type LT	N/A	N/A	Flare Type RT	N/A
N/A	Flare Slope LT (%)	N/A	N/A	Flare Slope RT (%)	0.0
N/A	Flare Traversable LT?	N/A	N/A	Flare Traversable RT?	N/A
N/A	Landing Length (in)	0.0	N/A	DWS Provided?	N/A
N/A	Landing Width (in)	0.0	N/A	DWS Contrast?	N/A
N/A	Landing Slope (%)	0.0	N/A	DWS Length (in)	N/A
N/A	Landing X Slope (%)	0.0	N/A	DWS Full Width?	N/A
N/A	Landing Curb? (Y/N)	N/A	N/A	DWS Offset LT (in)	N/A
N/A	Shared Landing?	N/A	N/A	DWS Offset RT (in)	N/A
N/A	Gutter Ponding?	0.0	N/A	Gutter Slope (%)	N/A
N/A	Gutter Lip Ht (in)	0.0	N/A	Gutter X Slope (%)	N/A
N/A	Painted X Walk1?	Yes		Road Slope (%)	2.9
	X Walk 1 Direction	To N		Road X Slope (%)	5.0
	X Walk 1 Width (in)	115.0		Clear Space?	N/A

X Walk 1 Slope (%)	2.9	N/A	Clear Space to XWalk (in)	N/A
	X Walk 1 X Slope (%)	5.0	N/A	Storm Grate/Utility Hazard?	N/A
N/A	Ramp inside XWalk1?	Yes		Storm Grate/Utility Type	
N/A	Any Obstructions?	N/A			N/A
	Obstruction Type		Yes	Surface Condition? (G/P)	Good
			N/A	Curb Slope (%)	15.6

Possible Solutions:

Remove & Replace Entire Ramp.

Total Cost: \$ **1600.00**
