# Access Compliance Report

## Public Rights-of-Way

### (Curb Ramps)

Intersection ID: 10424	Main Street: OPAL_ST	Cross Street: TUCKASEEGEE_RD	Location: NW
ADA ID: F68A45CAED50	Ramp Type: BlendTrans2	Initial Pass/Fail: Fail	Overall Compliance: No
Severity Score: 8.75			
Codes/Mitigation Info/Possible Solution		Field Measurements/Component Compliance

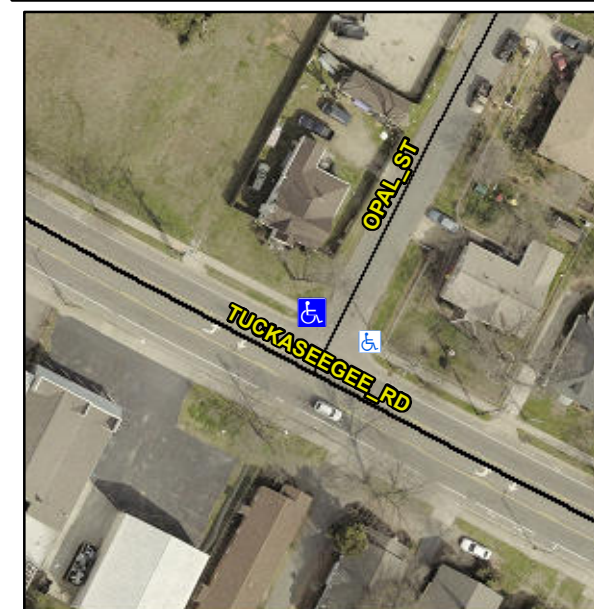
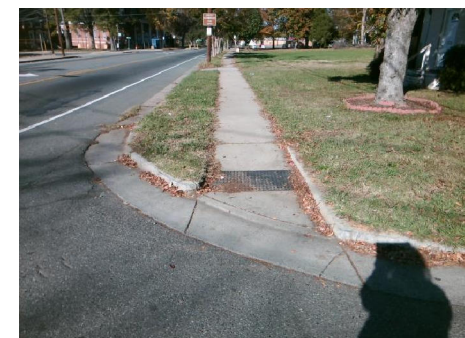
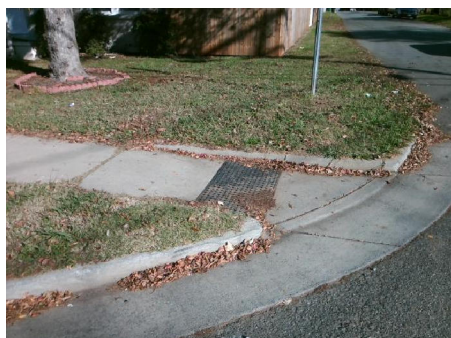
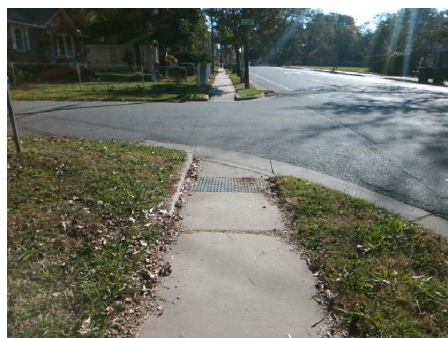
Compliance	Description	Data	Compliance	Description	Data
N/A	Ramp Length (in)	76.0	Yes	BlendTrans Slope (%)	4.8
No	Ramp Width (in)	47.5	Yes	BlendTrans XSlope (%)	1.9
N/A	Flare Type LT	N/A	N/A	Flare Type RT	N/A
N/A	Flare Slope LT (%)	N/A	N/A	Flare Slope RT (%)	N/A
N/A	Flare Traversable LT?	N/A	N/A	Flare Traversable RT?	N/A
N/A	Landing Length (in)	N/A	N/A	DWS Provided?	N/A
N/A	Landing Width (in)	N/A	N/A	DWS Contrast?	N/A
N/A	Landing Slope (%)	N/A	N/A	DWS Length (in)	N/A
N/A	Landing X Slope (%)	N/A	N/A	DWS Full Width?	N/A
N/A	Landing Curb? (Y/N)	N/A	N/A	DWS Offset (in)	N/A
N/A	Shared Landing?	N/A			
N/A	Gutter Ponding?	N/A	N/A	Gutter Slope (%)	N/A
N/A	Gutter Lip Ht (in)	N/A	N/A	Gutter X Slope (%)	N/A
N/A	Painted X Walk1?	No	N/A	Painted X Walk2?	N/A
	X Walk 1 Direction	To SE		X Walk 2 Direction	N/A
	X Walk 1 Width (in)	N/A		X Walk 2 Width (in)	N/A
	X Walk 1 Slope (%)	8.0		X Walk 2 Slope (%)	N/A
	X Walk 1 X Slope (%)	1.0		X Walk 2 X Slope (%)	N/A

N/A	Ramp inside XWalk1?	N/A	N/A	Ramp inside XWalk2?	N/A
	Road Slope (%)	1.0		Clear Space?	N/A
	Road X Slope (%)	8.0	N/A	Clear Space to XWalk (in)	N/A
N/A	Any Obstructions?	N/A	N/A	Storm Grate/Utility Hazard?	N/A
	Obstruction Type			Storm Grate/Utility Type	
		N/A			N/A
			Yes	Surface Condition? (G/P)	Good
			N/A	Curb Slope (%)	3.2

**Remove & Replace Curb Ramp With Two New Directional Ramps or Equivalent.**

**R304.5.1**

**\$ 3200.00**
