Access Compliance Report Public Rights-of-Way (Curb Ramps)

Intersection ID: 48140 Main Street: MCCAMEY_DR Cross Street: BUTTERBURR_DR Location: NE

ADA ID: F68B59BC1CE9 Ramp Type: BlendTrans1 Initial Pass/Fail: Fail Overall Compliance: No Severity Score: 10

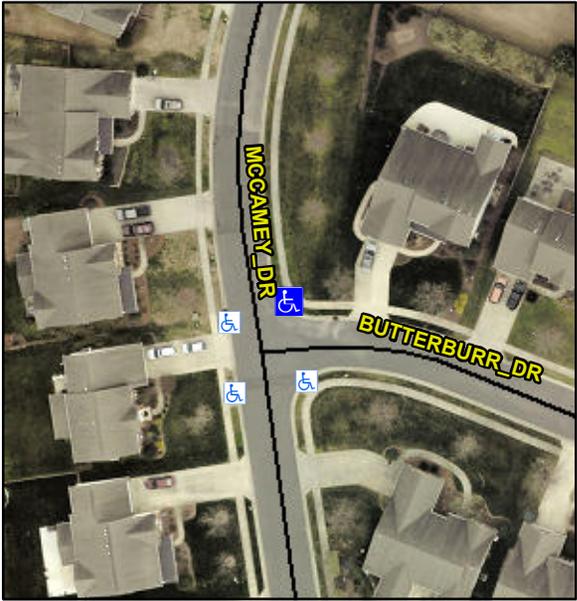
PROW/ADA:
Not Found, R304.5.1, R304.5.3

Compliance	Description	Data	Compliance	Description	Data
N/A	Ramp Length (in)	48.5	Yes	BlendTrans Slope (%)	4.6
No	Ramp Width (in)	44.0	No	BlendTrans XSlope (%)	2.4
N/A	Flare Type LT	N/A	N/A	Flare Type RT	N/A
N/A	Flare Slope LT (%)	N/A	N/A	Flare Slope RT (%)	N/A
N/A	Flare Traversable LT?	N/A	N/A	Flare Traversable RT?	N/A
N/A	Landing Length (in)	N/A	N/A	DWS Provided?	N/A
N/A	Landing Width (in)	N/A	N/A	DWS Contrast?	N/A
N/A	Landing Slope (%)	N/A	N/A	DWS Length (in)	N/A
N/A	Landing X Slope (%)	N/A	N/A	DWS Full Width?	N/A
N/A	Landing Curb? (Y/N)	N/A	N/A	DWS Offset (in)	N/A
N/A	Shared Landing?	N/A			
N/A	Gutter Ponding?	N/A	N/A	Gutter Slope (%)	N/A
N/A	Gutter Lip Ht (in)	N/A	N/A	Gutter X Slope (%)	N/A
N/A	Painted X Walk1?	No	N/A	Painted X Walk2?	No
	X Walk 1 Direction	To W		X Walk 2 Direction	To S
	X Walk 1 Width (in)	N/A		X Walk 2 Width (in)	N/A
	X Walk 1 Slope (%)	2.4		X Walk 2 Slope (%)	0.7
	X Walk 1 X Slope (%)	1.0		X Walk 2 X Slope (%)	2.4

N/A	Ramp inside XWalk1?	N/A	N/A	Ramp inside XWalk2?	N/A
	Road Slope (%)	1.8		Clear Space?	N/A
	Road X Slope (%)	1.9	N/A	Clear Space to XWalk (in)	N/A
N/A	Any Obstructions?	N/A	N/A	Storm Grate/Utility Hazard?	N/A
	Obstruction Type			Storm Grate/Utility Type	
		N/A			N/A
Yes	Surface Condition? (G/P)		Yes		Good
No	Curb Slope (%)		No		11.8

Possible Solutions:
Remove & Replace Curb Ramp With Two New Directional Ramps or Equivalent.
