# Access Compliance Report

## Public Rights-of-Way

### (Curb Ramps)

| Intersection ID: 48198 | Main Street: RIVERGATE_PY | Cross Street: S_TRYON_ST | Location: SE |

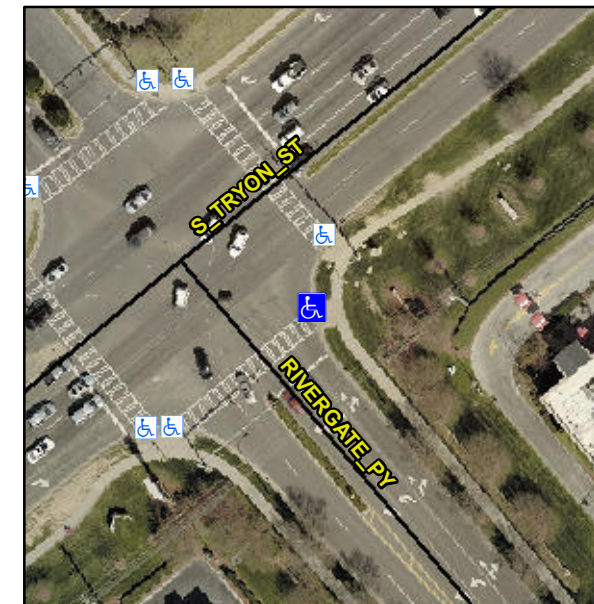
**Not Found, R304.5.1**

| Compliance | Description | Data | Compliance | Description | Data |
|---|---|---|---|---|---|
| No | Ramp Width (in) | 37.0 | Yes | Ramp XSlope (%) | 0.5 |

**Remove & Replace Entire Ramp.**

Total Cost: \$ 1850.00

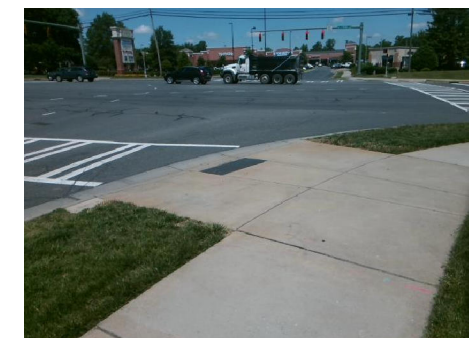
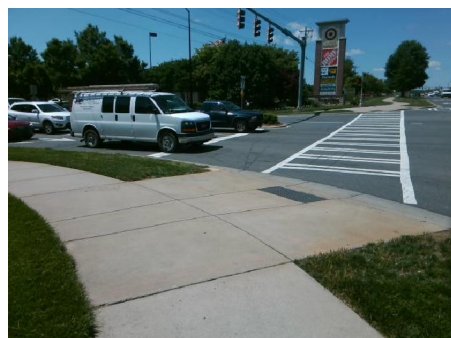
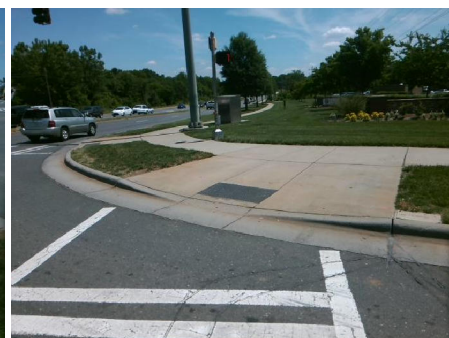
| Compliance | Description | Data | Compliance | Description | Data |
|---|---|---|---|---|---|
| N/A | Ramp Length (in) | 98.0 | Yes | Ramp Slope (%) | 6.5 |
