Access Compliance Report

Public Rights-of-Way

(Curb Ramps)

Intersection ID: 19337	Main Street: PARK_RD	Cross Street: N/A	Location: NE
ADA ID: F692E1C56B1F	Ramp Type: PerpDiag	Initial Pass/Fail: Fail	Overall Compliance: No
			Severity Score: 21.25

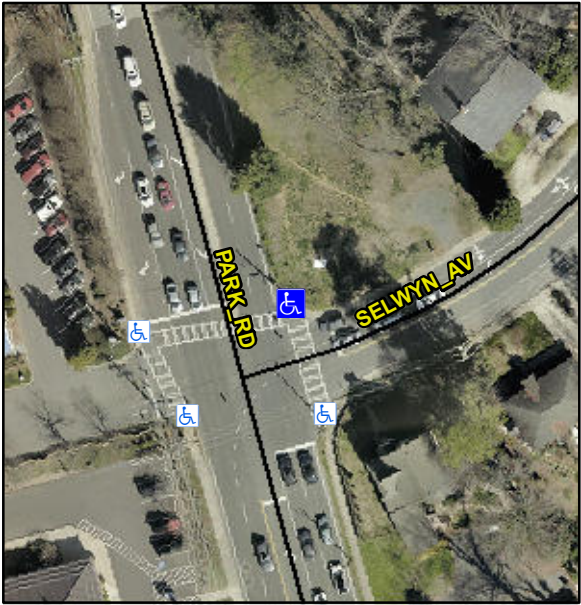
Possible Solutions:		Compliance	Description	Data
	Remove & Replace Curb Ramp With Two New Directional Ramps or Equivalent.		N/A	Ramp Length (in)	47.0
			No	Ramp Width (in)	43.0
			N/A	Flare Type LT	N/A
			N/A	Flare Slope LT (%)	N/A
			N/A	Flare Traversable LT?	N/A
			N/A	Landing Length (in)	N/A
			N/A	Landing Width (in)	N/A
			N/A	Landing Slope (%)	N/A
			N/A	Landing X Slope (%)	N/A
<p>Surveyor Notes:</p> <p>N/A</p> <p>PROW/ADA:</p> <p>R304.5.1, R304.5.3</p>			N/A	Flare Type RT	N/A
			N/A	Flare Slope RT (%)	N/A
			N/A	Flare Traversable RT?	N/A
			N/A	DWS Provided?	N/A
			N/A	DWS Contrast?	N/A
			N/A	DWS Length (in)	N/A
			N/A	DWS Full Width?	N/A
			N/A	DWS Offset (in)	N/A
			N/A	Shared Landing?	N/A
			N/A	Gutter Ponding?	N/A
<p>Total Cost:</p> <p>\$ 3200.00</p>			N/A	Gutter Lip Ht (in)	N/A
			N/A	Painted X Walk1?	Yes
				X Walk 1 Direction	To W

N/A	X Walk 1 Width (in)	86.0
				X Walk 1 Slope (%)	0.1
				X Walk 1 X Slope (%)	0.6
			N/A	Ramp inside XWalk1?	Yes
				Road Slope (%)	3.2
				Road X Slope (%)	1.6
			N/A	Any Obstructions?	N/A
				Obstruction Type	
			N/A	Ramp inside XWalk2?	Yes
				Clear Space?	N/A
				Clear Space to XWalk (in)	N/A
			N/A	Storm Grate/Utility Hazard?	N/A
				Storm Grate/Utility Type	
			N/A	Surface Condition? (G/P)	N/A
			Yes		Good
