Access Compliance Report

Public Rights-of-Way

(Curb Ramps)

Intersection ID: 10121	Main Street: DOLPHIN_LN	Cross Street: RUTH_DR	Location: W
ADA ID: F699033C67D2	Ramp Type: Directional1	Initial Pass/Fail: Fail	Overall Compliance: No
		Severity Score: 1.25

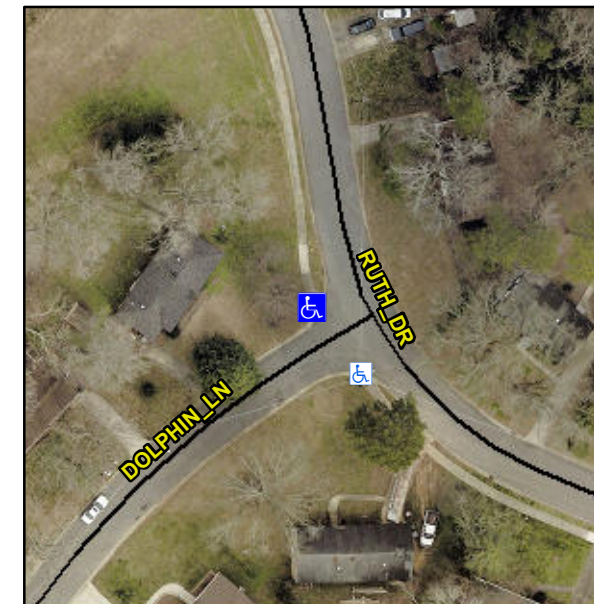
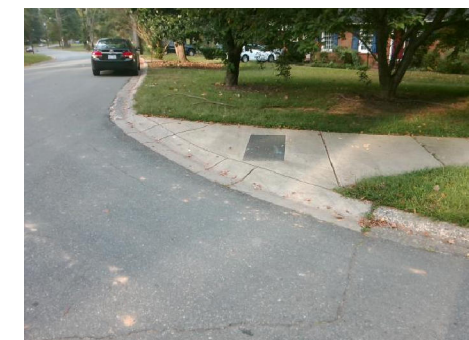
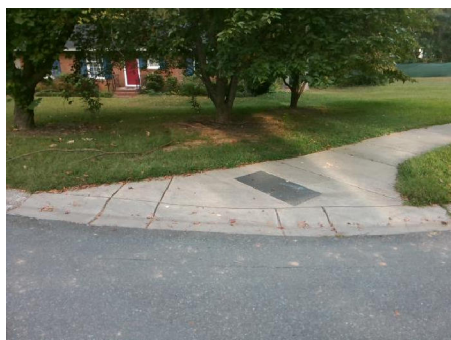
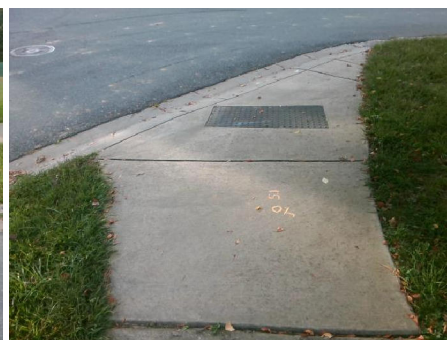
Compliance	Description	Data	Compliance	Description	Data
N/A	Ramp Length (in)	91.5	N/A	Grade Break?	N/A
Yes	Ramp Width (in)	60.0	N/A	Grade Break Slope (%)	0.0
Yes	Ramp Slope (%)	5.1	N/A	Grade Break XSlope (%)	0.0
No	Ramp XSlope (%)	4.0			
N/A	Flare Type LT	N/A	N/A	Flare Type RT	N/A
N/A	Flare Slope LT (%)	N/A	N/A	Flare Slope RT (%)	0.0
N/A	Flare Traversable LT?	N/A	N/A	Flare Traversable RT?	N/A
N/A	Landing Length (in)	0.0	N/A	DWS Provided?	N/A
N/A	Landing Width (in)	0.0	N/A	DWS Contrast?	N/A
N/A	Landing Slope (%)	0.0	N/A	DWS Length (in)	N/A
N/A	Landing X Slope (%)	0.0	N/A	DWS Full Width?	N/A
N/A	Landing Curb? (Y/N)	N/A	N/A	DWS Offset LT (in)	N/A
N/A	Shared Landing?	N/A	N/A	DWS Offset RT (in)	N/A
N/A	Gutter Ponding?	0.0	N/A	Gutter Slope (%)	N/A
N/A	Gutter Lip Ht (in)	1.0	N/A	Gutter X Slope (%)	N/A
N/A	Painted X Walk1?	No		Road Slope (%)	4.2
	X Walk 1 Direction	To SE		Road X Slope (%)	0.9
	X Walk 1 Width (in)	N/A		Clear Space?	N/A

X Walk 1 Slope (%)	4.2	N/A	Clear Space to XWalk (in)	N/A
	X Walk 1 X Slope (%)	0.9	N/A	Storm Grate/Utility Hazard?	N/A
N/A	Ramp inside XWalk1?	N/A		Storm Grate/Utility Type	
N/A	Any Obstructions?	N/A			N/A
	Obstruction Type		Yes	Surface Condition? (G/P)	Good
			N/A	Curb Slope (%)	20.6

Remove & Replace Entire Ramp.

R304.5.3
