# Access Compliance Report

## Public Rights-of-Way

### (Curb Ramps)

| Intersection ID: 12779 | Main Street: E_TRADE_ST | Cross Street: S_DAVIDSON_ST | Location: S |

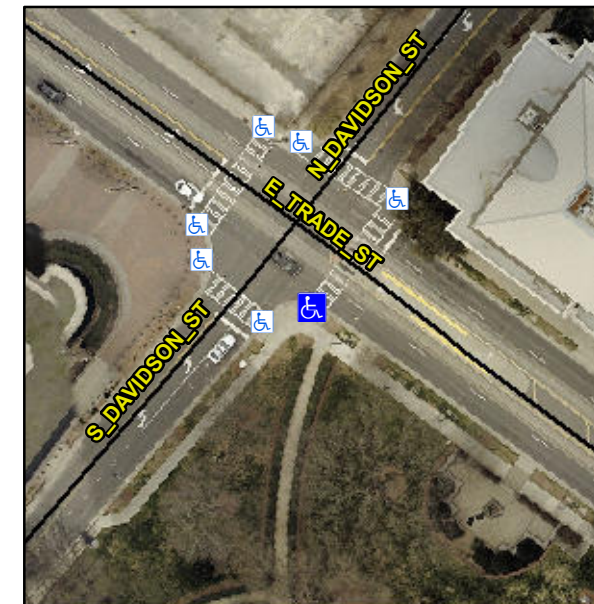
**Not Found, R304.2.1, R304.5.4**

| Compliance | Description | Data | Compliance | Description | Data |
|---|---|---|---|---|---|
| No | Landing Width (in) | 47.0 | Yes | DWS Contrast? | Yes |
| Yes | Gutter Ponding? | No | No | Gutter Slope (%) | 6.4 |

**Remove & Replace Entire Ramp.  
Remove & Replace Gutter.**
