Access Compliance Report

Public Rights-of-Way

(Curb Ramps)

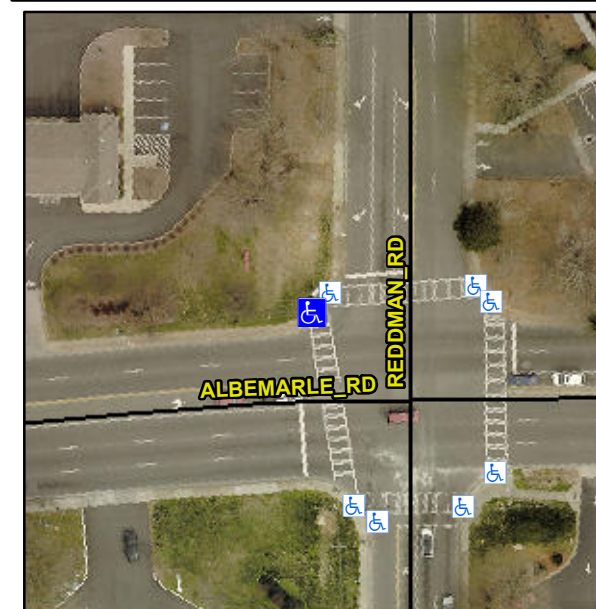
Intersection ID: 15094	Main Street: ALBEMARLE_RD	Cross Street: REDDMAN_RD	Location: NW
ADA ID: F6B0EFD51E89	Ramp Type: Perp	Initial Pass/Fail: Fail	Overall Compliance: No
Severity Score: 22.5			
Codes/Mitigation Info/Possible Solution		Field Measurements/Component Compliance

Not Found, R304.5.1, R304.2.2

Compliance	Description	Data	Compliance	Description	Data
N/A	Ramp Length (in)	60.0	No	Ramp Slope (%)	8.5
No	Ramp Width (in)	40.0	Yes	Ramp XSlope (%)	2.6
N/A	Flare Type LT	N/A	N/A	Flare Type RT	N/A
N/A	Flare Slope LT (%)	N/A	N/A	Flare Slope RT (%)	N/A
N/A	Flare Traversable LT?	N/A	N/A	Flare Traversable RT?	N/A
N/A	Landing Length (in)	N/A	N/A	DWS Provided?	N/A
N/A	Landing Width (in)	N/A	N/A	DWS Contrast?	N/A
N/A	Landing Slope (%)	N/A	N/A	DWS Length (in)	N/A
N/A	Landing X Slope (%)	N/A	N/A	DWS Full Width?	N/A
N/A	Landing Curb? (Y/N)	N/A	N/A	DWS Offset (in)	N/A
N/A	Shared Landing?	N/A			
N/A	Gutter Ponding?	N/A	N/A	Gutter Slope (%)	N/A
N/A	Gutter Lip Ht (in)	N/A	N/A	Gutter X Slope (%)	N/A
N/A	Painted X Walk1?	Yes	N/A	Painted X Walk2?	N/A
	X Walk 1 Direction	To S		X Walk 2 Direction	N/A
N/A	X Walk 1 Width (in)	114.0	N/A	X Walk 2 Width (in)	N/A
	X Walk 1 Slope (%)	2.6		X Walk 2 Slope (%)	N/A
	X Walk 1 X Slope (%)	3.7		X Walk 2 X Slope (%)	N/A

N/A	Ramp inside XWalk1?	Yes	N/A	Ramp inside XWalk2?	N/A
	Road Slope (%)	N/A	N/A	Clear Space?	N/A
	Road X Slope (%)	N/A	N/A	Clear Space to XWalk (in)	N/A
N/A	Any Obstructions?	N/A	N/A	Storm Grate/Utility Hazard?	N/A
	Obstruction Type			Storm Grate/Utility Type	
		N/A			N/A
		Yes		Surface Condition? (G/P)	Good

Possible Solutions:

Remove & Replace Entire Ramp.
