Access Compliance Report

Public Rights-of-Way

(Curb Ramps)

Intersection ID: N/A	Main Street: N_COMMUNITY_HOUSE_RD	Cross Street: ENDAHVEN_LN	Location: SW
ADA ID: F6B8081FA607	Ramp Type: Perp	Initial Pass/Fail: Fail	Overall Compliance: No
Severity Score: 22.5			
Codes/Mitigation Info/Possible Solution		Field Measurements/Component Compliance

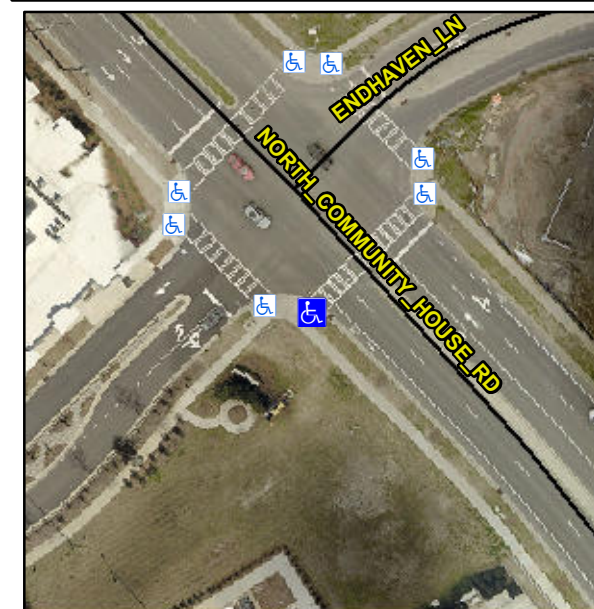
Not Found, R304.5.1, R304.2.2, R304.5.3

Compliance	Description	Data	Compliance	Description	Data
N/A	Ramp Length (in)	81.5	No	Ramp Slope (%)	8.7
No	Ramp Width (in)	47.0	No	Ramp XSlope (%)	2.2
N/A	Flare Type LT	N/A	N/A	Flare Type RT	N/A
N/A	Flare Slope LT (%)	N/A	N/A	Flare Slope RT (%)	N/A
N/A	Flare Traversable LT?	N/A	N/A	Flare Traversable RT?	N/A
N/A	Landing Length (in)	N/A	N/A	DWS Provided?	N/A
N/A	Landing Width (in)	N/A	N/A	DWS Contrast?	N/A
N/A	Landing Slope (%)	N/A	N/A	DWS Length (in)	N/A
N/A	Landing X Slope (%)	N/A	N/A	DWS Full Width?	N/A
N/A	Landing Curb? (Y/N)	N/A	N/A	DWS Offset (in)	N/A
N/A	Shared Landing?	N/A			
N/A	Gutter Ponding?	N/A	N/A	Gutter Slope (%)	N/A
N/A	Gutter Lip Ht (in)	N/A	N/A	Gutter X Slope (%)	N/A
N/A	Painted X Walk1?	Yes	N/A	Painted X Walk2?	N/A
	X Walk 1 Direction	To NE		X Walk 2 Direction	N/A
N/A	X Walk 1 Width (in)	114.0	N/A	X Walk 2 Width (in)	N/A
	X Walk 1 Slope (%)	3.7		X Walk 2 Slope (%)	N/A
	X Walk 1 X Slope (%)	1.9		X Walk 2 X Slope (%)	N/A

N/A	Ramp inside XWalk1?	Yes	N/A	Ramp inside XWalk2?	N/A
	Road Slope (%)	N/A	N/A	Clear Space?	N/A
	Road X Slope (%)	N/A	N/A	Clear Space to XWalk (in)	N/A
N/A	Any Obstructions?	N/A	N/A	Storm Grate/Utility Hazard?	N/A
	Obstruction Type			Storm Grate/Utility Type	
		N/A			N/A
		Yes		Surface Condition? (G/P)	Good

Possible Solutions:

Remove & Replace Entire Ramp.
